WRECK POND BROOK WATERSHED

2015 Habitat Assessment Report

November 2015

Prepared by:
Jenna Krug, Habitat Restoration Coordinator
Capt. Al Modjeski, Habitat Restoration Director
American Littoral Society

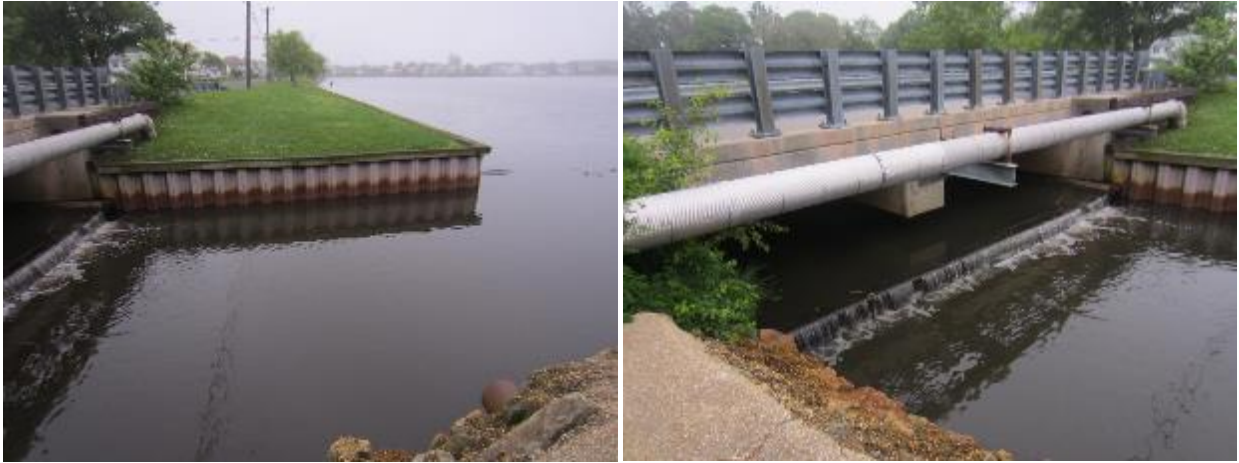
Figure 1. Black Creek Weir, downstream Wreck Pond side

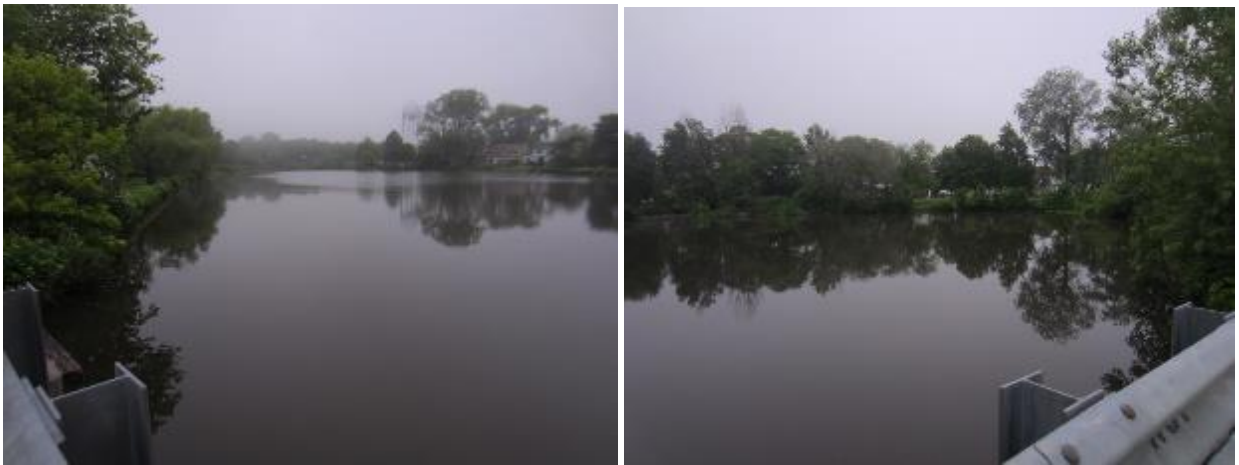
Figure 2. Black Creek Weir, upstream Black Creek side (first pond).

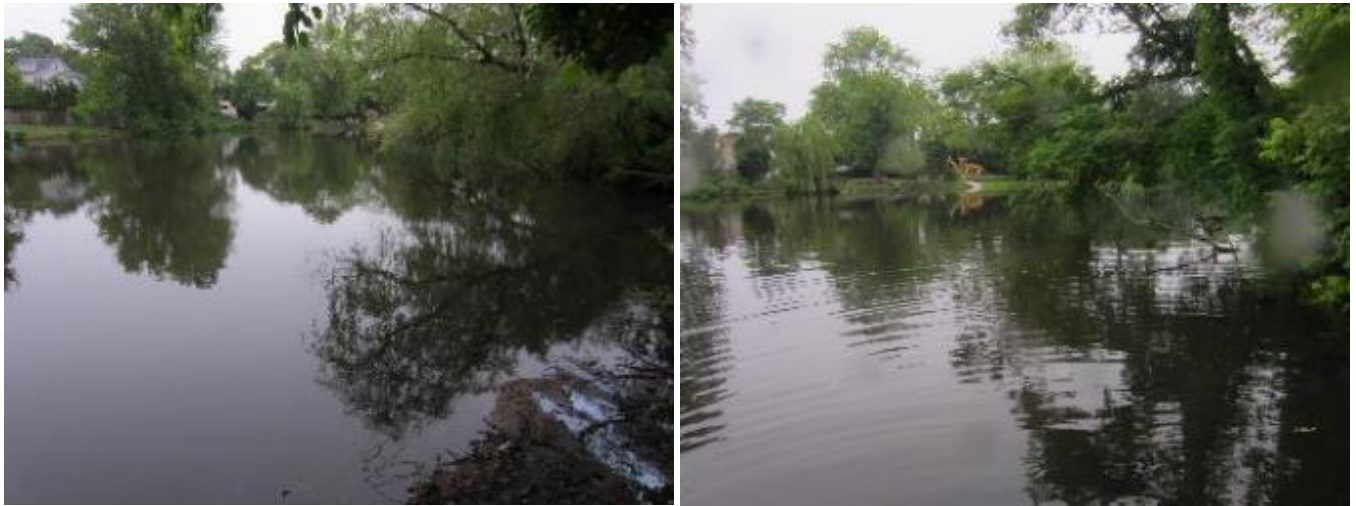
Railroad Tracks/Culvert (Figure 9). Water quality taken (see Table 3 in report). Depth ~ 15-20cm; could be a fish barrier in very low flow conditions. Duckweed, oily sheen on water surface.

Figure 9. Upstream of railroad (RR) bridge (second pond).

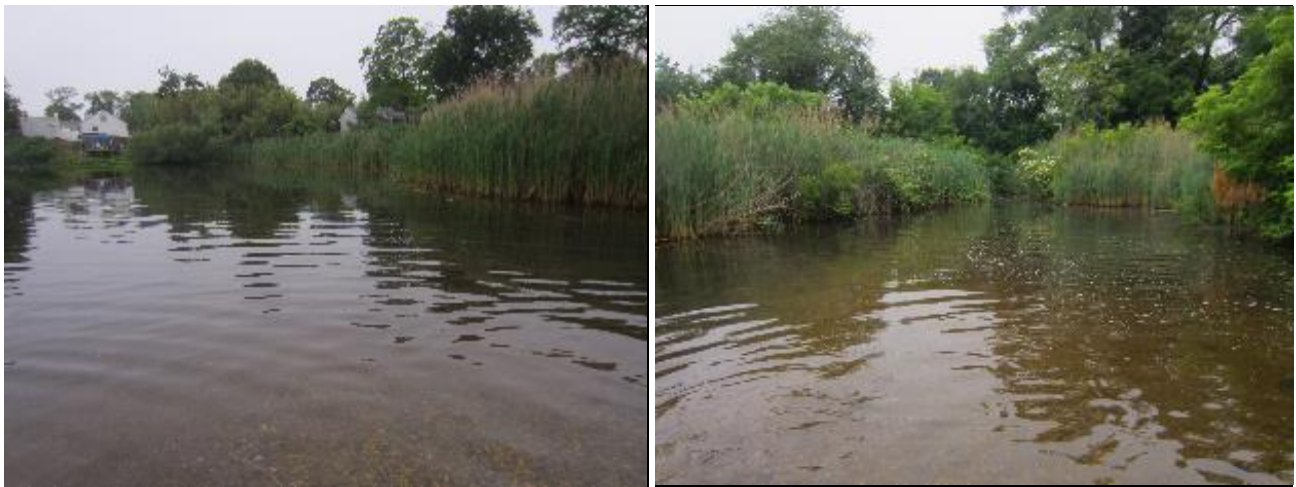
Figure 10. Gravel bar in upper area of second pond (~30m downstream of Route 71). Minimum depth ~10cm.

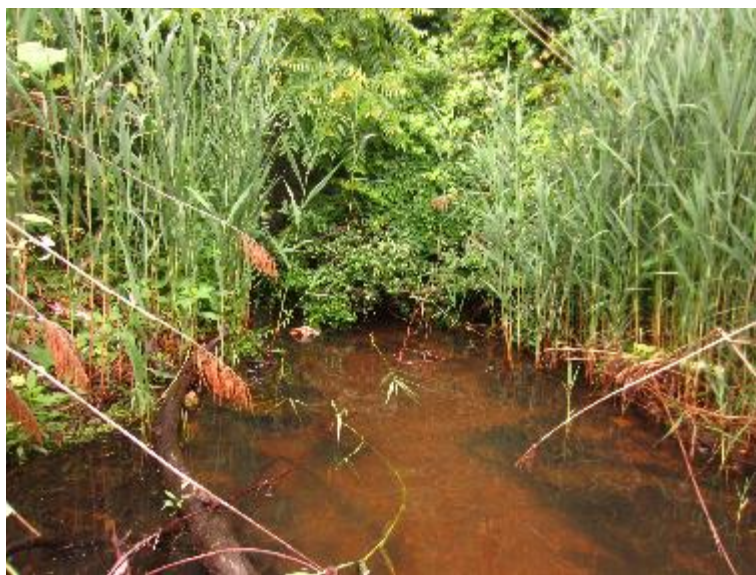
Approx. 40m downstream of Rt. 71 – gravel bed about 10m x 5m to about 10m x 1m. Many carp observed around the gravel bar located approximately 30m downstream of Route 71 Bridge and between the gravel bar and the bridge (Figure 11).

Figure 11. Approximately 10 m downstream of Route 71 bridge.

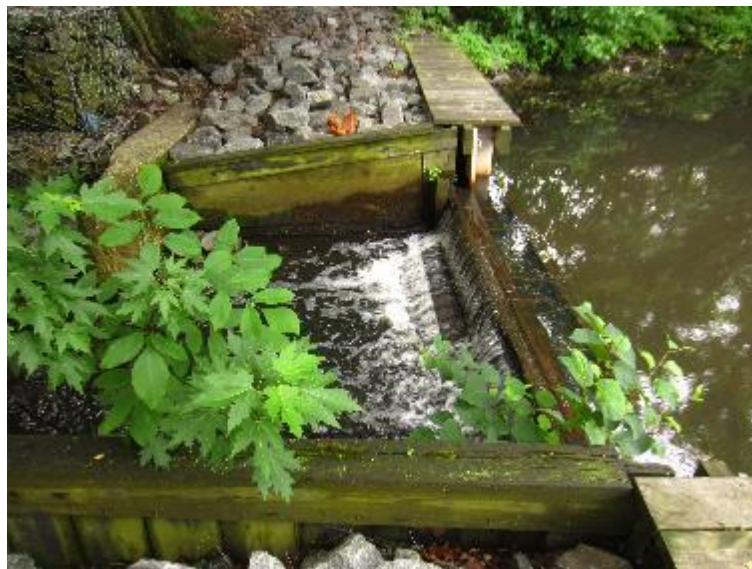
Figure 14. Weir approximately 5m upstream of Route 71 bridge.

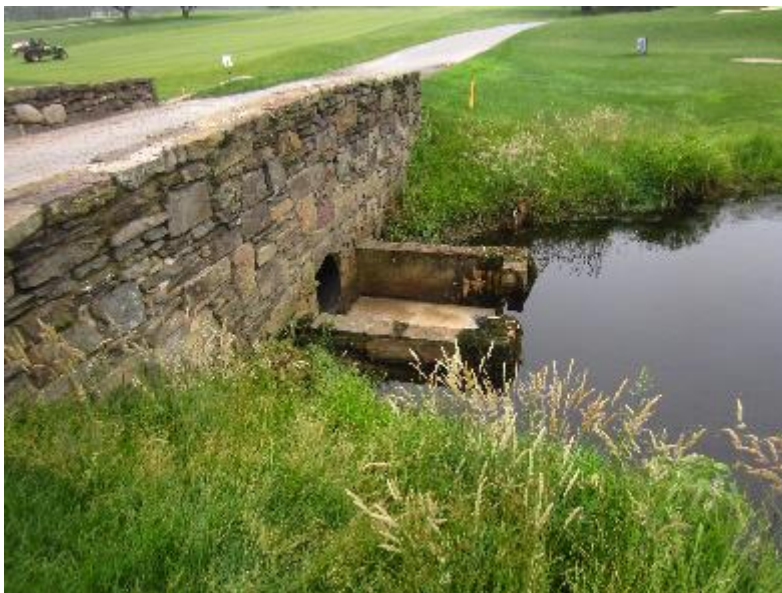
Figure 19. Culvert separating fourth pond and fifth pond/run.

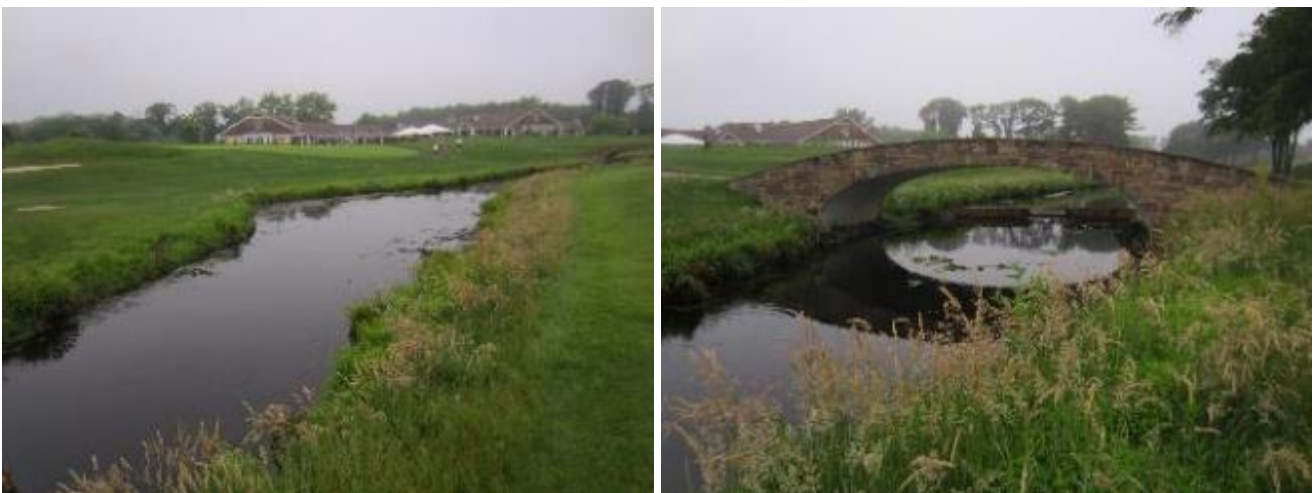
Figure 20. Fifth pond/run to Warren Ave. First of three weirs located along this "run."

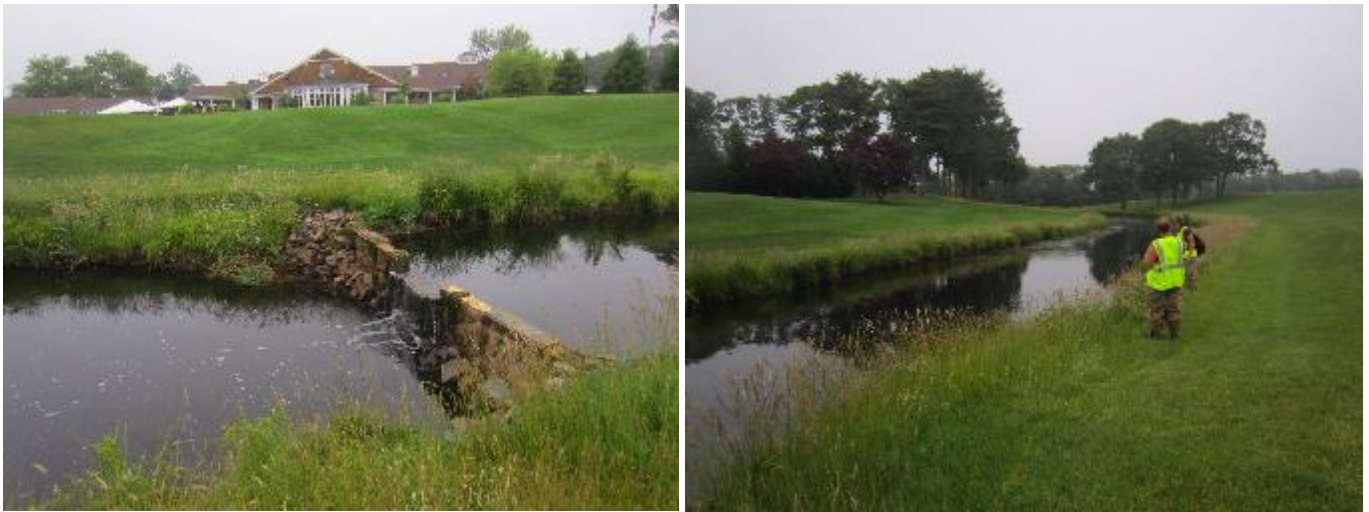
Figure 21. Second weir and above in fifth pond/run.

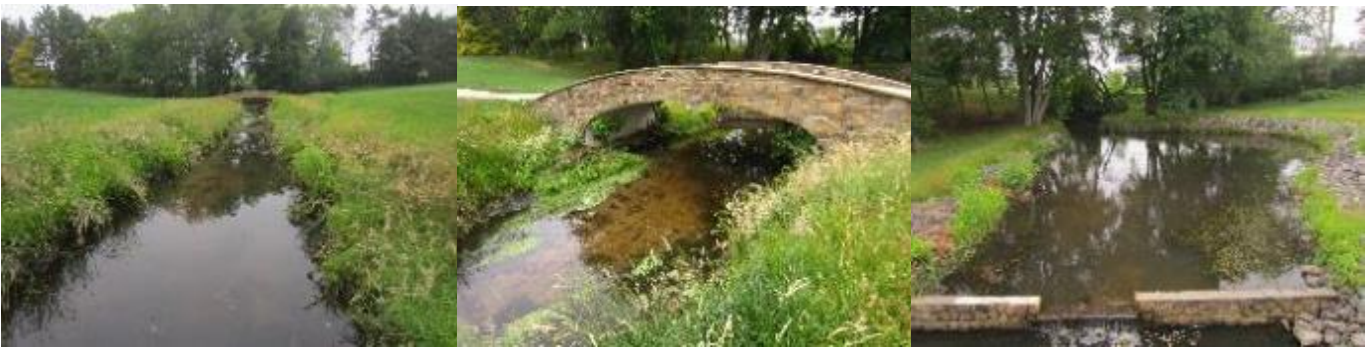
Figure 22. Upstream end of fifth pond/run and third weir.

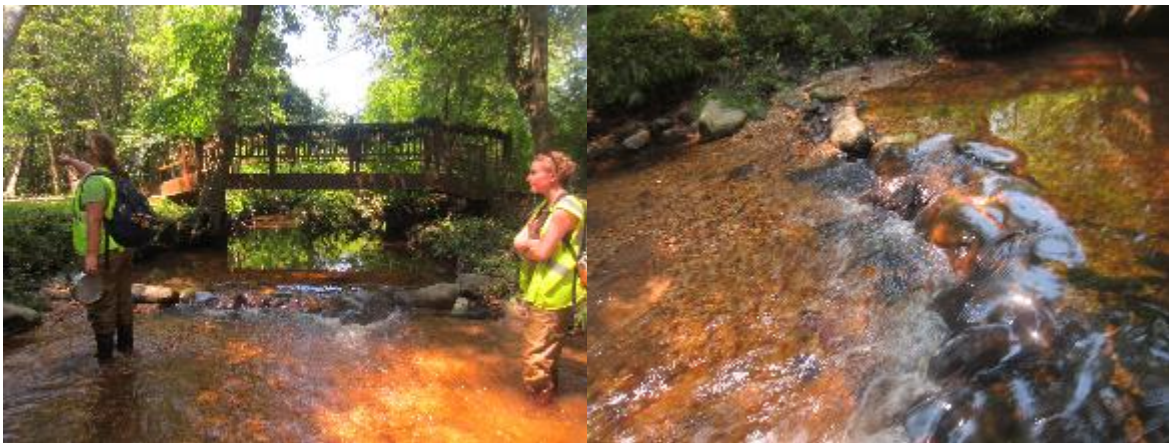
Figure 28. Hand-placed rock dam just upstream of confluence with Wreck Pond Brook

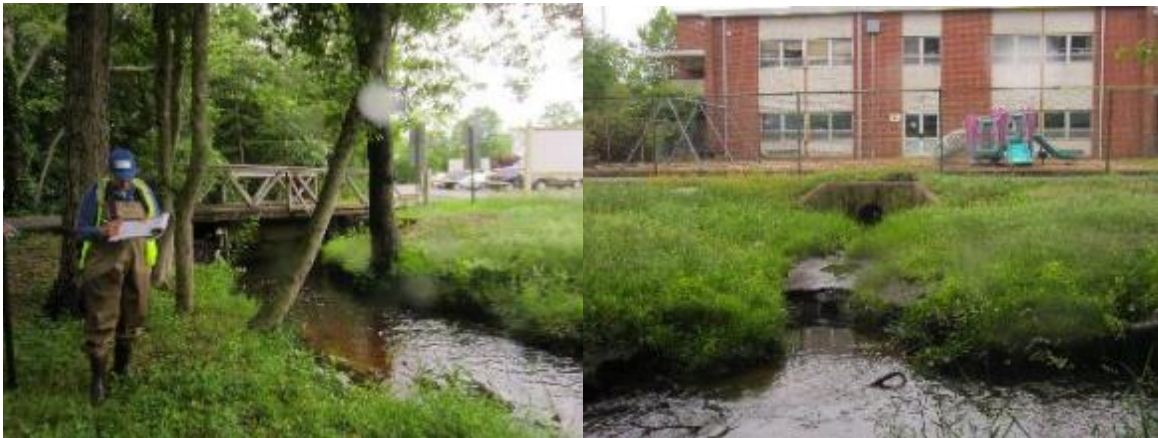
Figure 33. Footbridge and storm drain culvert at the downstream end of the Old Mill Elementary School property.

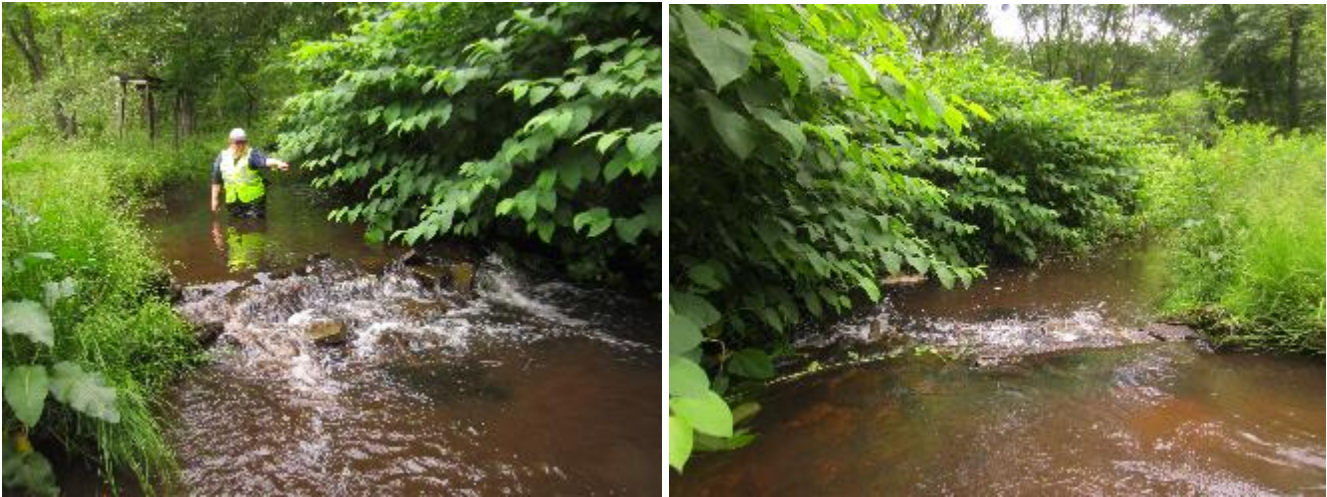
Just upstream – a small check dam made of concrete rubble about 50cm high; potential barrier in low flow conditions GPS: 40.14227N 74.06844W (Figure 59)

Figure 59. Small check dam located at GPS: 40.14227N 74.06844W. Looking upstream (left photo), looking downstream (right photo).

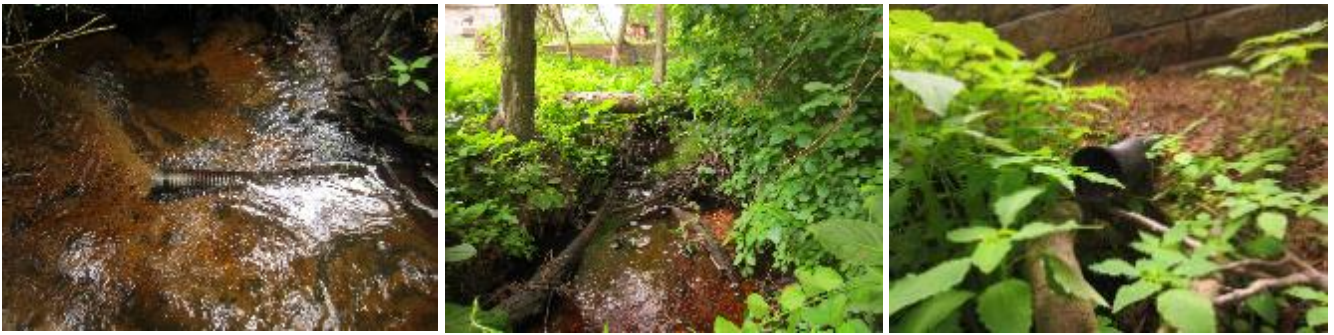
Figure 61. Black pipes emptying into creek below Crystalbrook Dr.

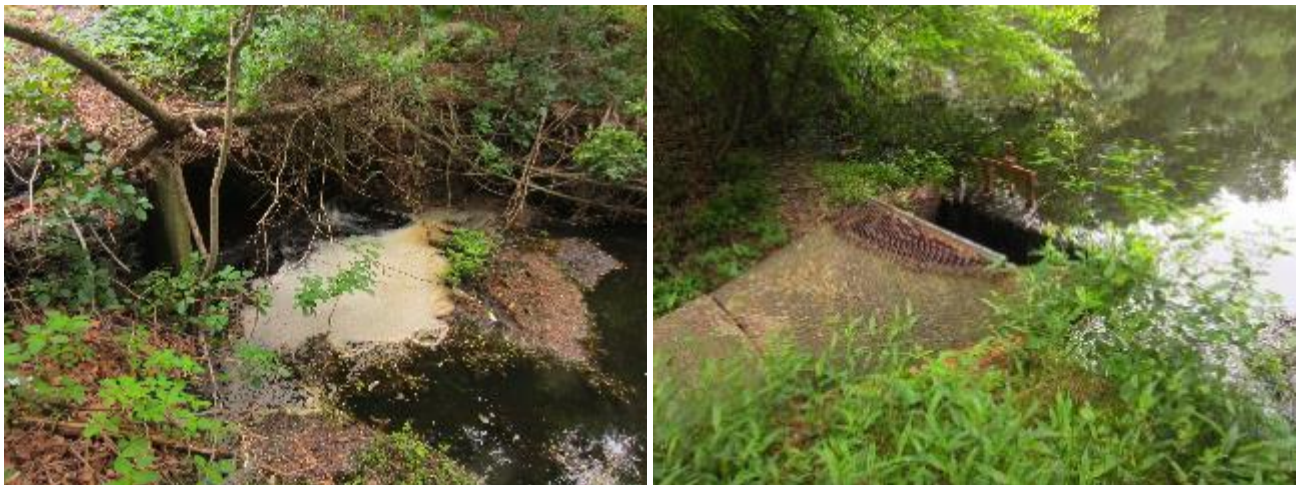
Figure 63. Culvert at downstream end of Crystalbrook Dr. (left photo) and upstream (right photo).

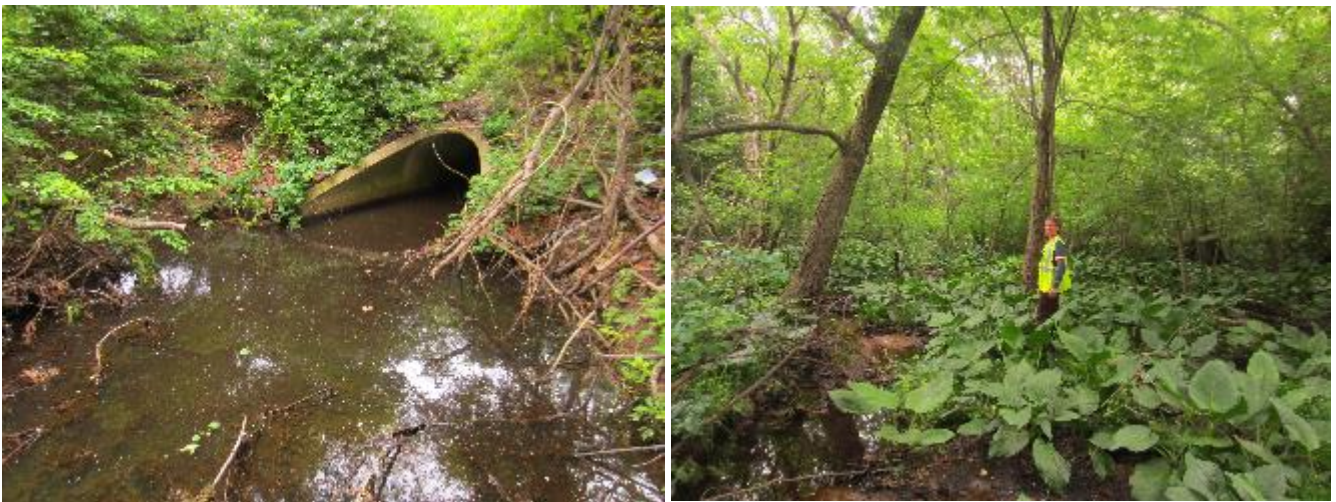
Figure 65. Culvert downstream end of Hiddenbrook Dr. (left photo), habitat downstream of Hiddenbrook Dr. (right photo).

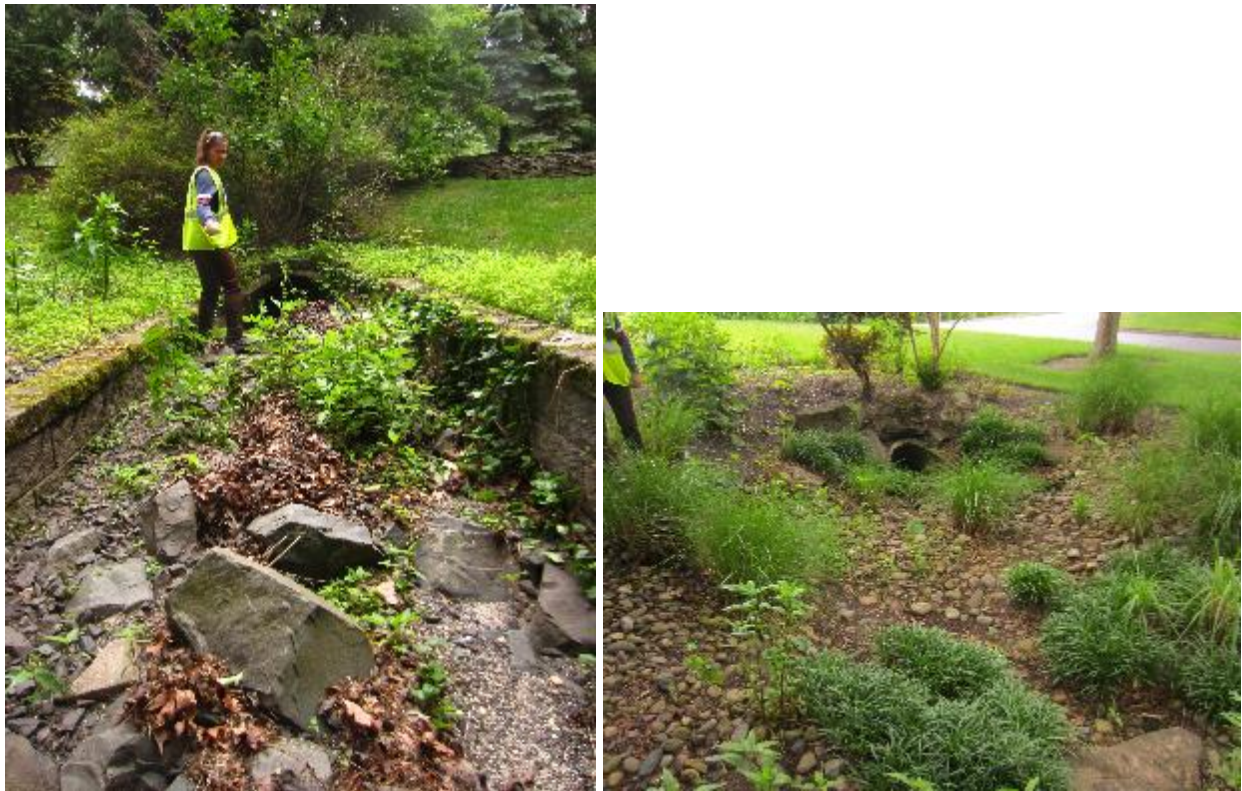
Figure 67. Culvert at Shadowbrook Dr. (downstream left photo, upstream right photo). End location for June 4, 2015 survey.

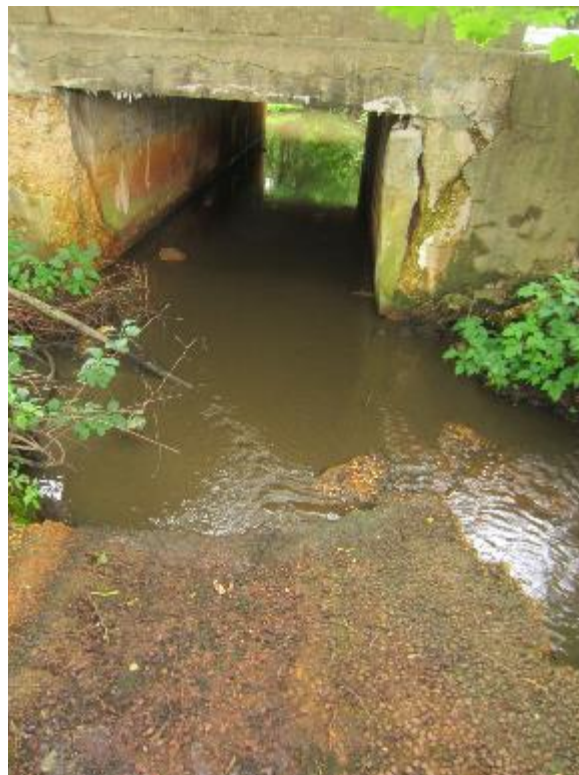
Figure 68. Culvert at Allaire Rd. Start location of June 16, 2015 survey.

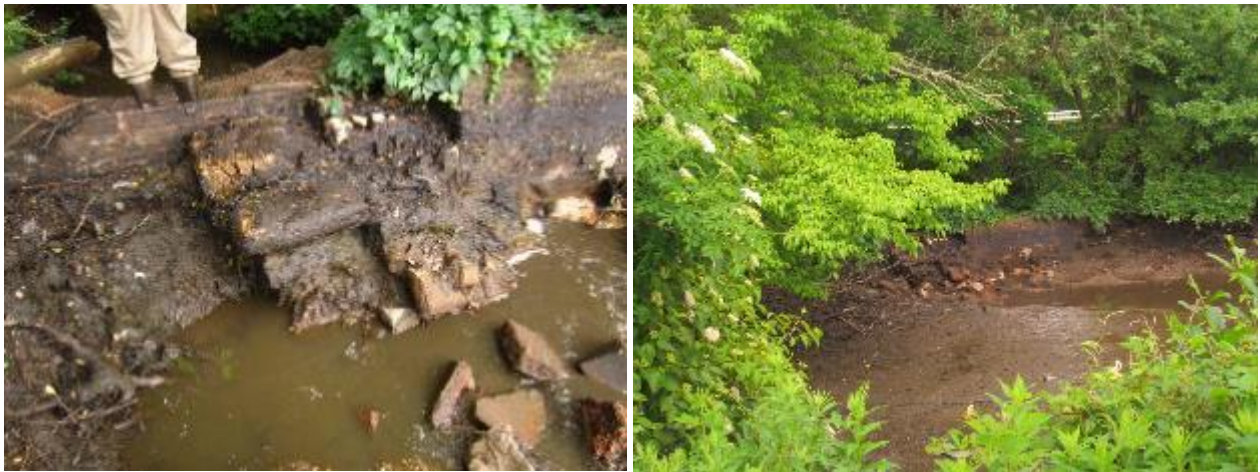
Upstream of road (Bel-Aire Golf Course; Monmouth County) – broken concrete weir (Figure 69) – water is flowing through; top of structure approx. 3-3.5 ft high; would be fish barrier if not broken, so not currently a barrier; GPS: 40.15071N 74.09148W ±20'; mudflat above broken weir, muddy, mucky bottom, sunk in about 50cm near edge (Figure 70)

Figure 69. Broken weir upstream of Allaire Rd (downstream of mudflat in above photo).

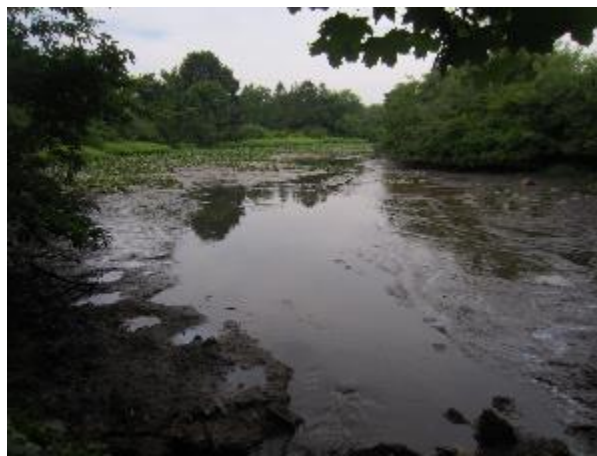
Figure 70. Mudflat upstream of Allaire Rd. (Bel-Aire Golf Course). Start location for June 16, 2015 survey.

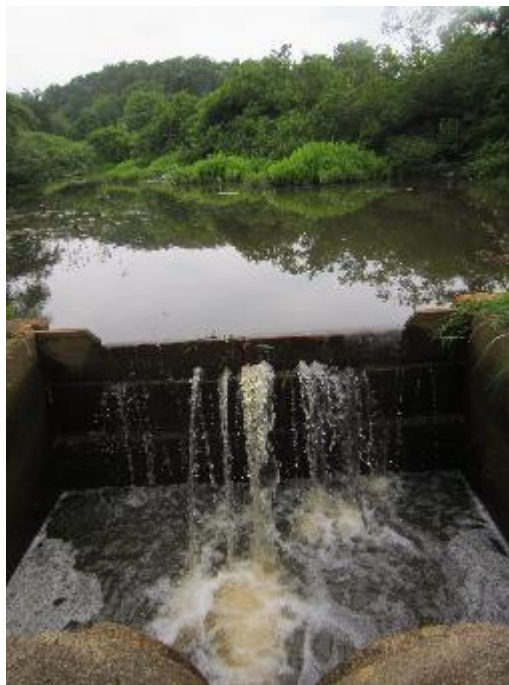
Broken wooden weir GPS: 40.15263N 74.09178W ±11' (Figure 73)

Figure 73. Broken wooden weir. GPS: 40.15263N 74.09178W ±11'.

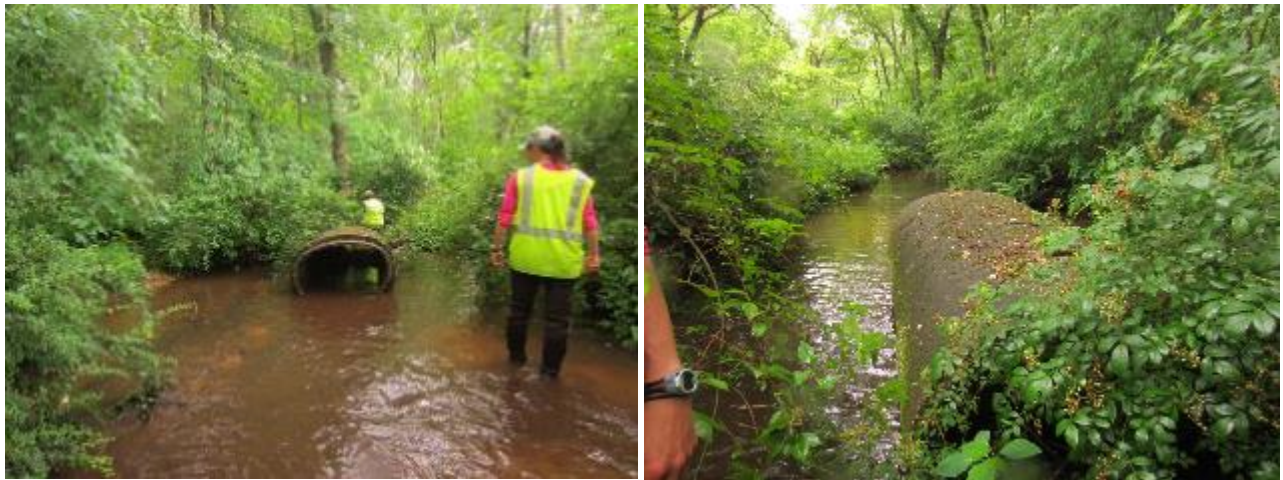
Figure 78. Large, single concrete pipe at GPS: 40.14717N 74.07893W ±36' (looking upstream left photo, downstream right photo).

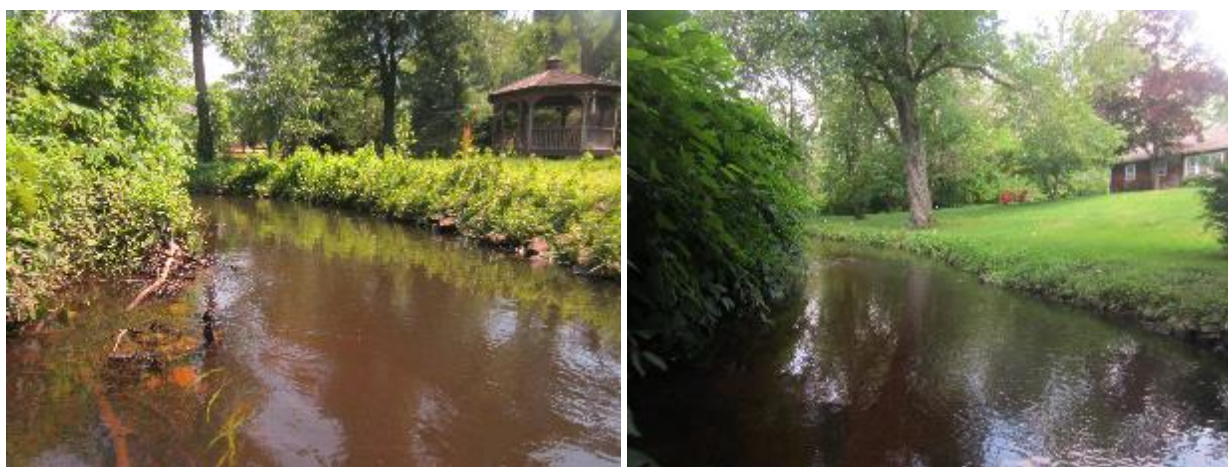
+12m – house on north bank, wide lawn and riprap on stream bank; creek average depth 30cm, max depth 110cm, 60% gravel, 40% sand substrate; one American eel 65cm length observed (Figure 85)

Figure 85. Properties along Wreck Pond Brook, rip rap on banks.

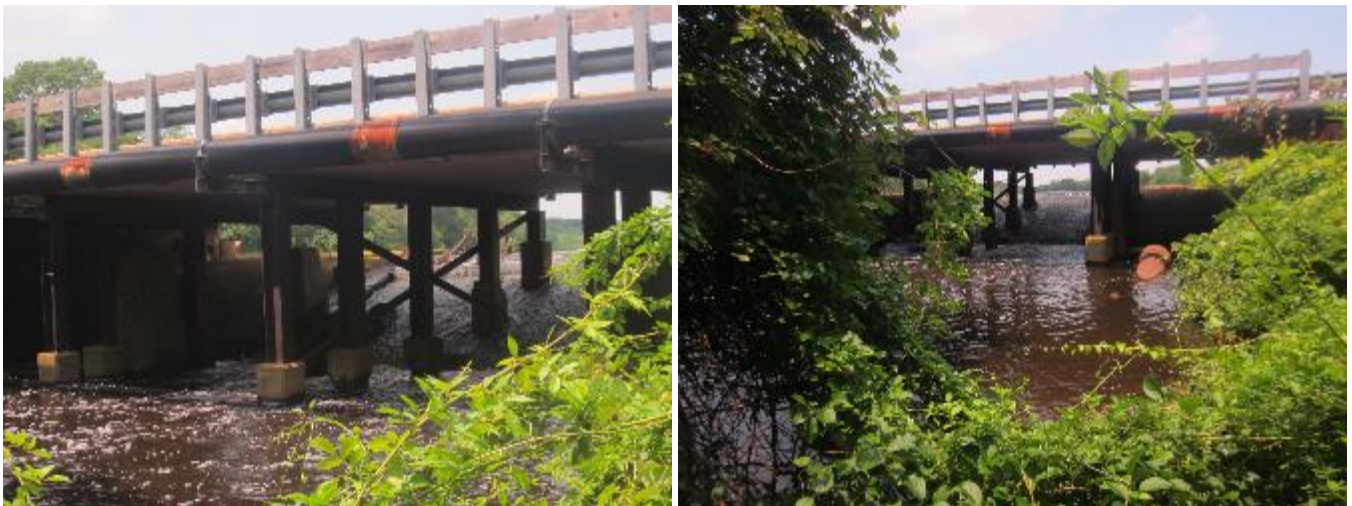
Figure 102. Wreck Pond Brook, Allaire Road Bridge and Dam. GPS: 40.15295N 74.061533W ±17'.
