WRECK POND BROOK WATERSHED

2015 Habitat Assessment Report

November 2015

Prepared by:
Jenna Krug, Habitat Restoration Coordinator
Capt. Al Modjeski, Habitat Restoration Director
American Littoral Society

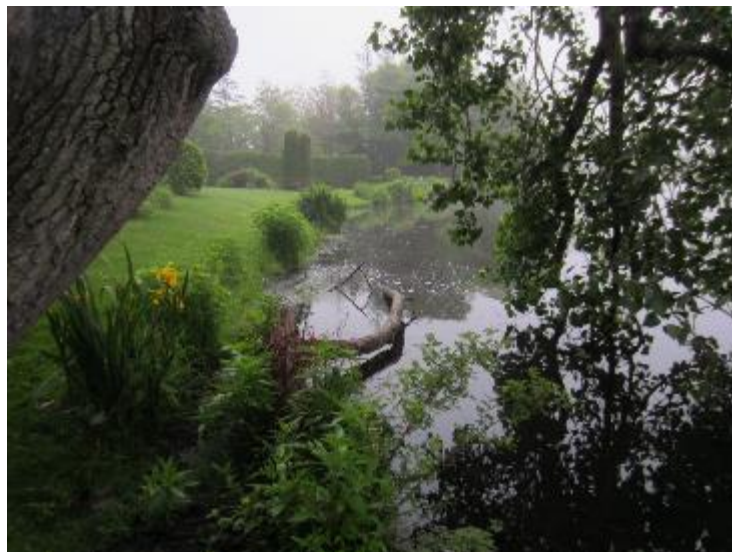
Figure 5. Looking downstream along northern bank just below DPW yard.

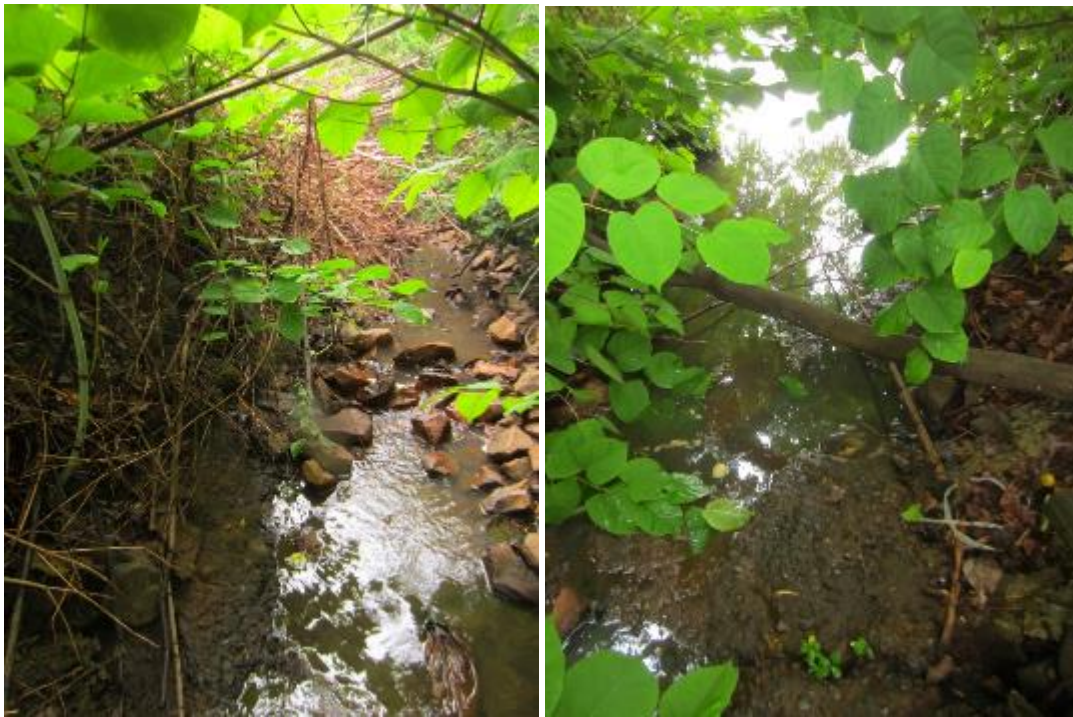
Figure 6. Small side channel just between fence and DPW yard.

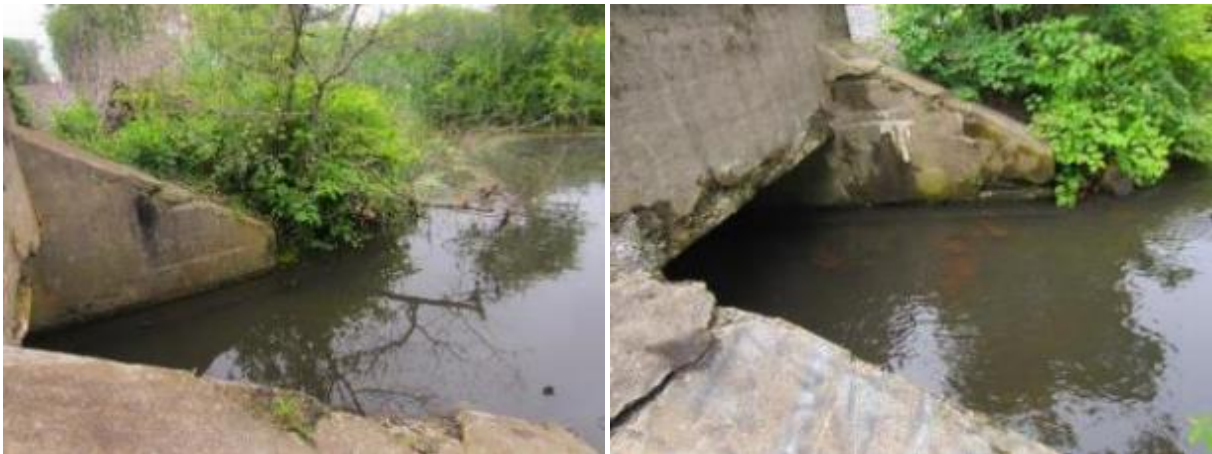
Figure 8. Downstream end of railroad (RR) bridge.

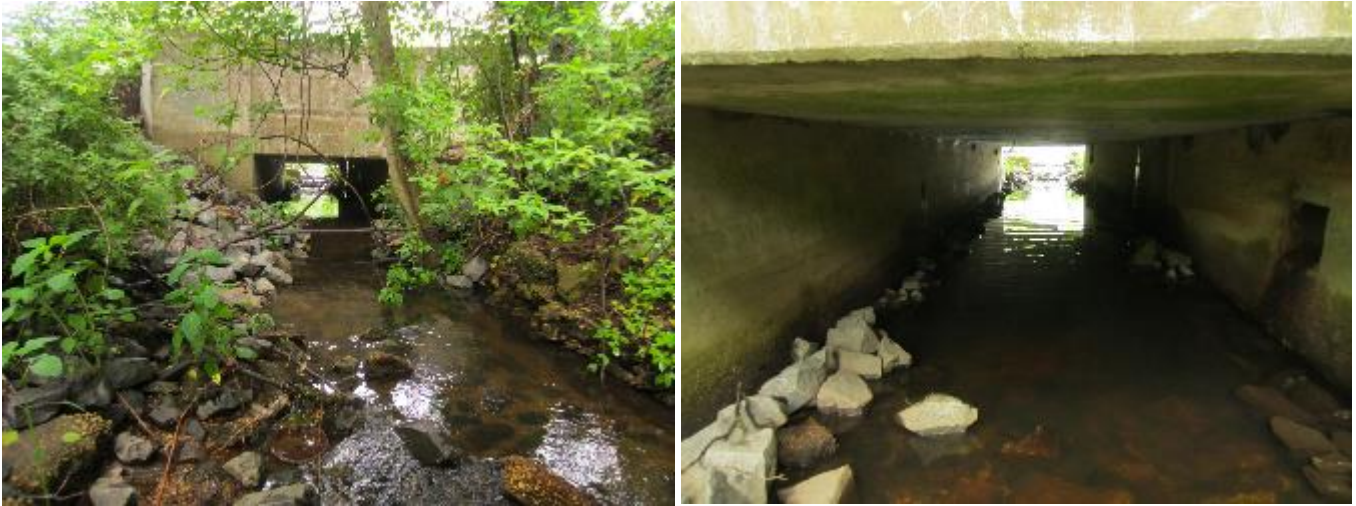
Figure 12. Just downstream and below the Route 71 bridge.

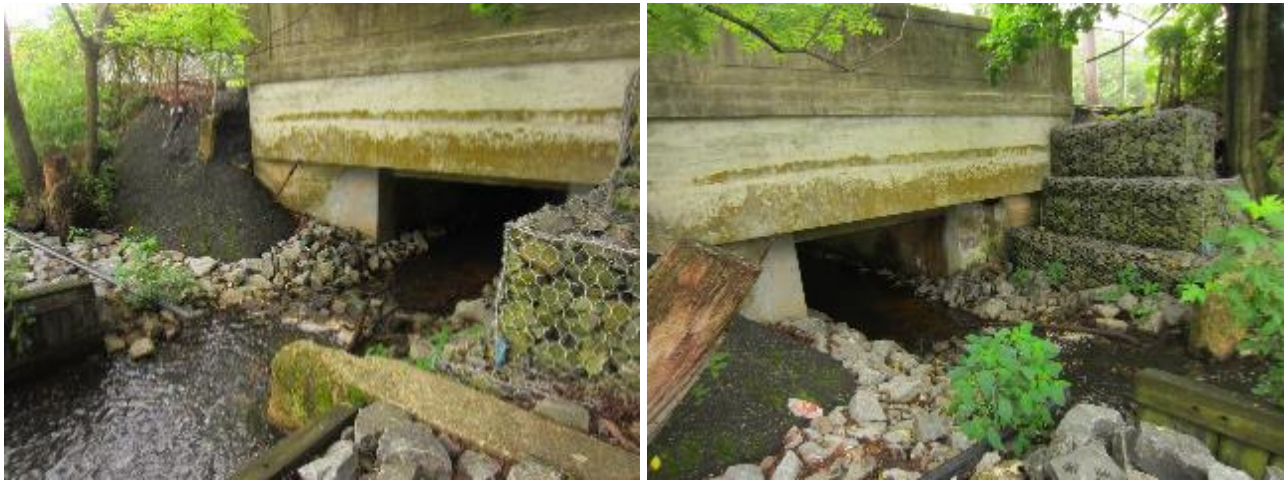
Figure 13. Upstream of the Route 71 bridge.

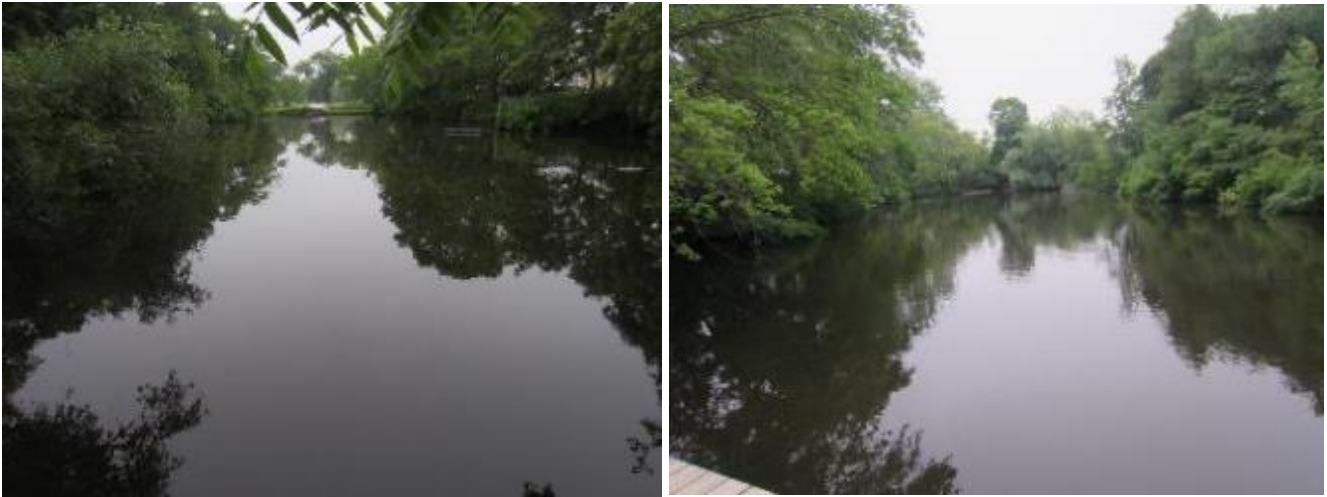
Figure 15. Upstream of Route 71 bridge. First pond on Spring Lake Golf Club property.

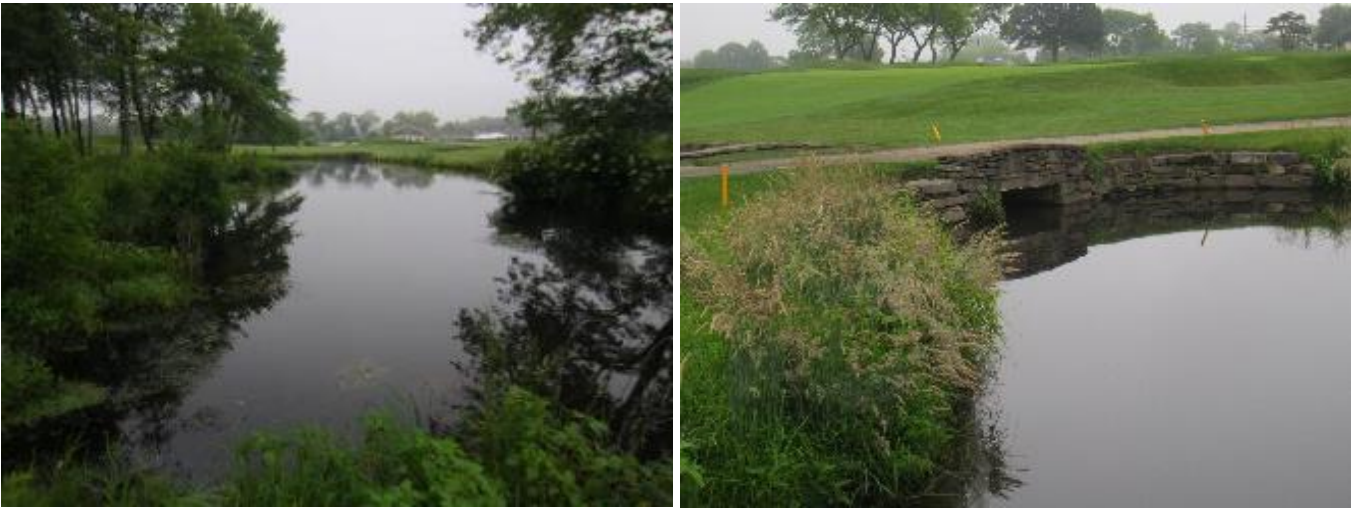
Figure 17. Third pond on Spring Lake GC. Passageway between third and fourth ponds.

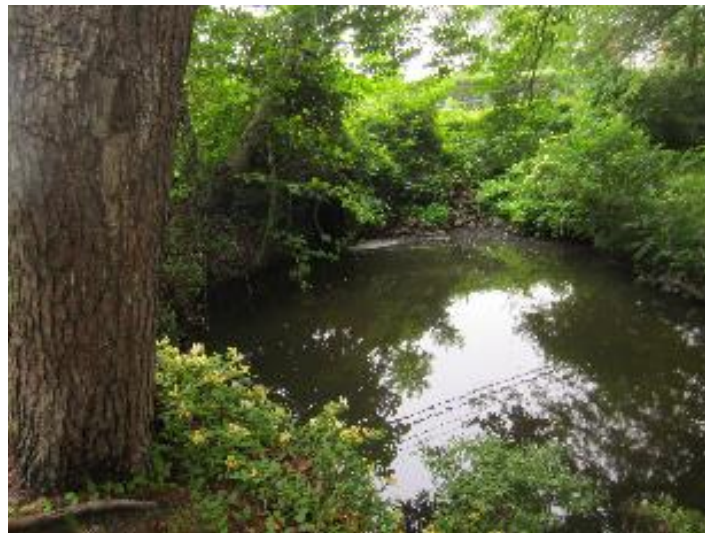
Figure 23. Culvert at Warren Rd.

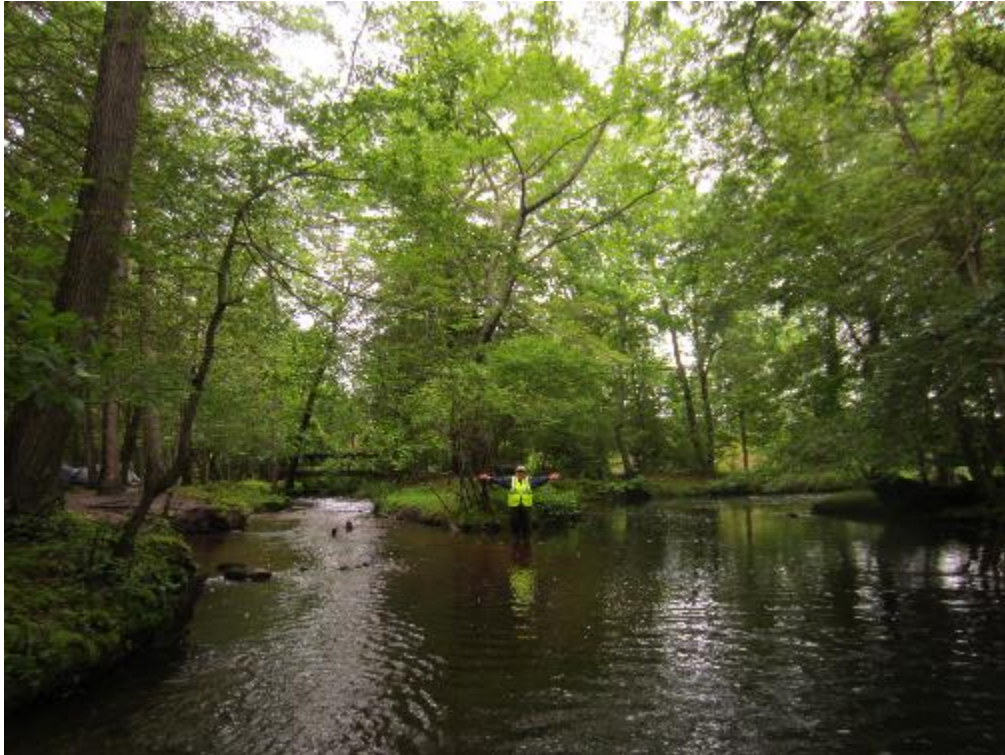
Figure 27. Confluence of Hannabrand Brook (South) and Wreck Pond Brook (North)

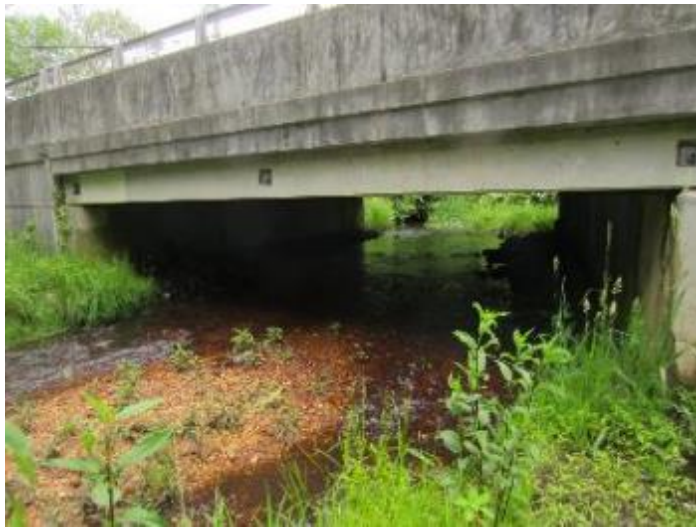
Figure 29. Old Mill Road Bridge

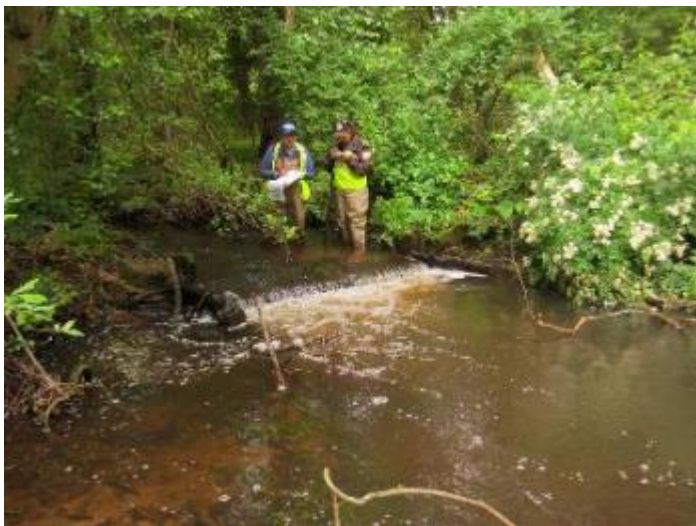
Figure 31. Wooden weir just upstream of old wooden footbridge

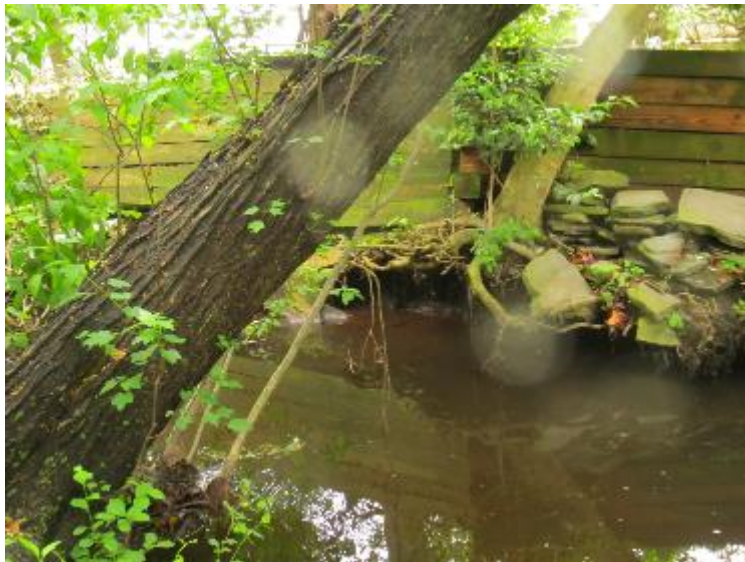
Figure 32. Undercut bank and wooden bulkhead just downstream of the Old Mill Elementary School

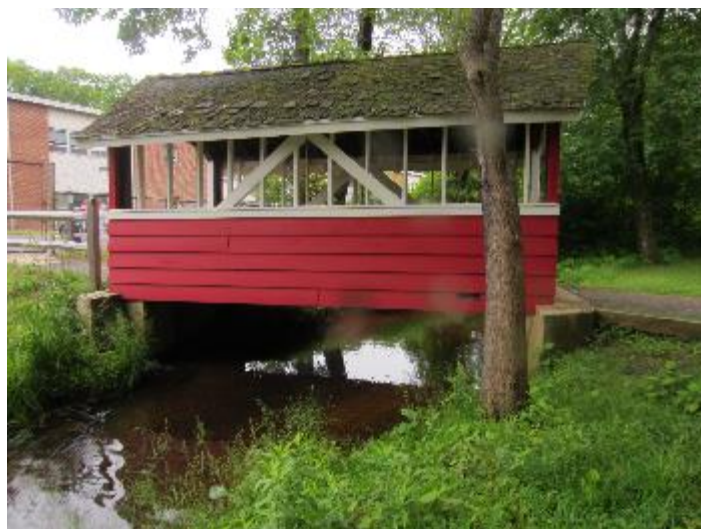
Figure 34. Second footbridge at the Old Mill Elementary School property.

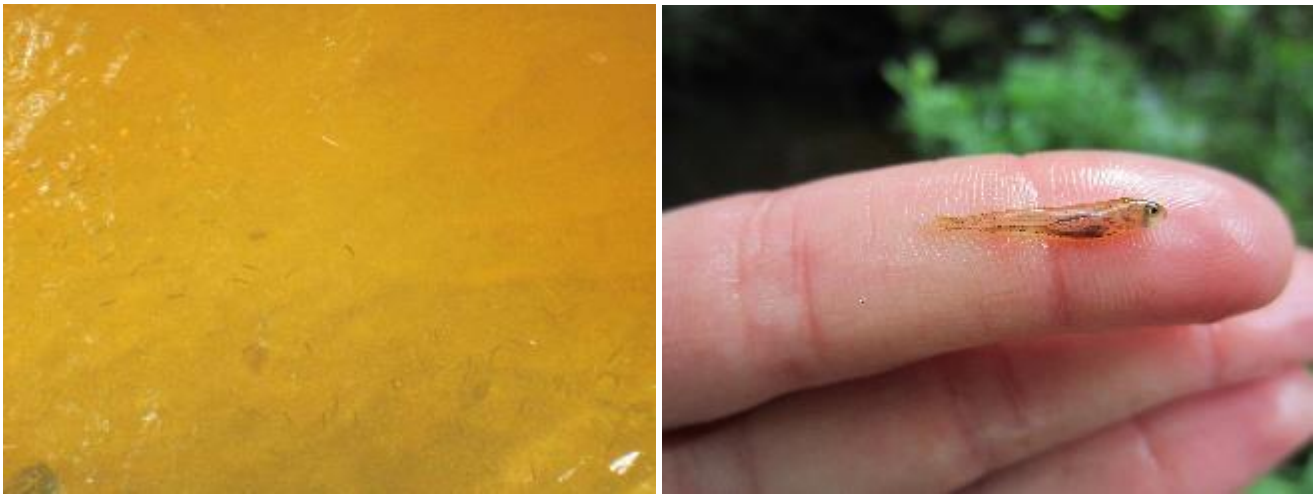
Figure 35. School of juvenile fish observed approximately 20m upstream of the Old Mill ES property.

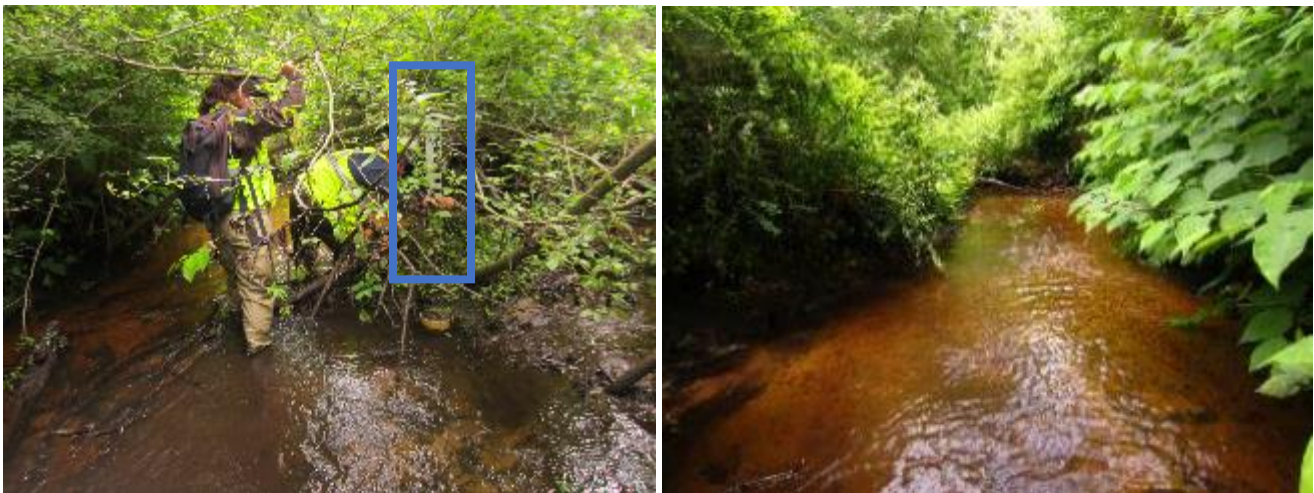
Water level marker stream gauge GPS: 40.141867N 74.058083W ±32' (Figure 37)

Figure 37. Stream gauge in creek (left photo; blue outline), Creek habitat upstream of stream gauge (right photo).

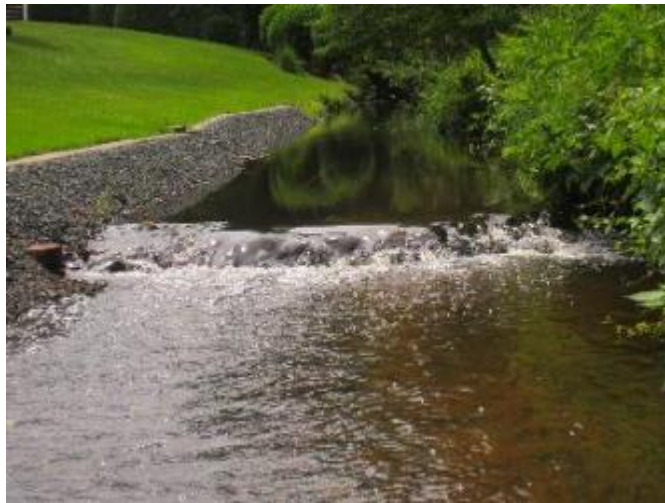
Half way along stone revetment is a small check dam, 30cm high from bottom, 20cm high from water surface, probably not a barrier GPS: 40.141233N 74.0592W ±18' (Figure 39)

Figure 39. Small, concrete check dam located half way along residential property.

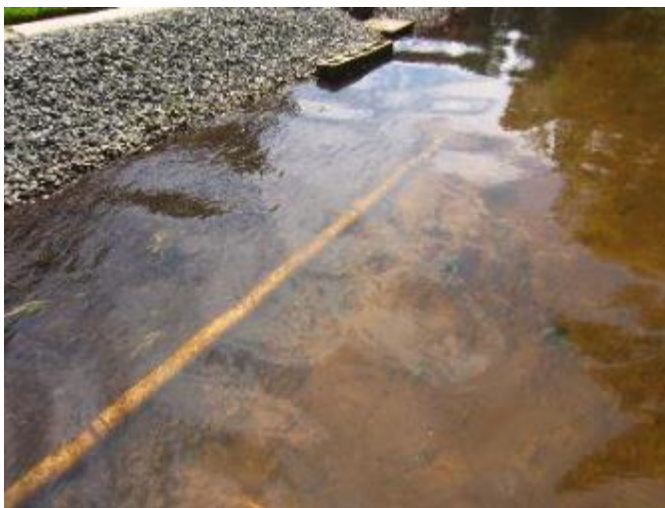
+10m – 10+ damselfly adults, 1 dragonfly adult observed; 3 small, black pipes emptying into creek, 2 white slotted pipes in creek (Figure 40)

Figure 40. White, slotted pipe in creek.

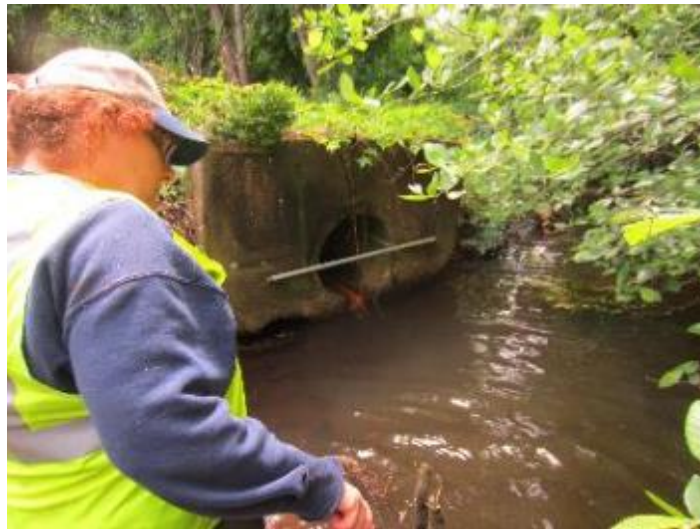
+10m – concrete culvert emptying into creek (storm drain from development?) GPS: 40.141017N 74.059617W ±18' (Figure 41)

Figure 41. Concrete culvert located just upstream of stone revetment property.

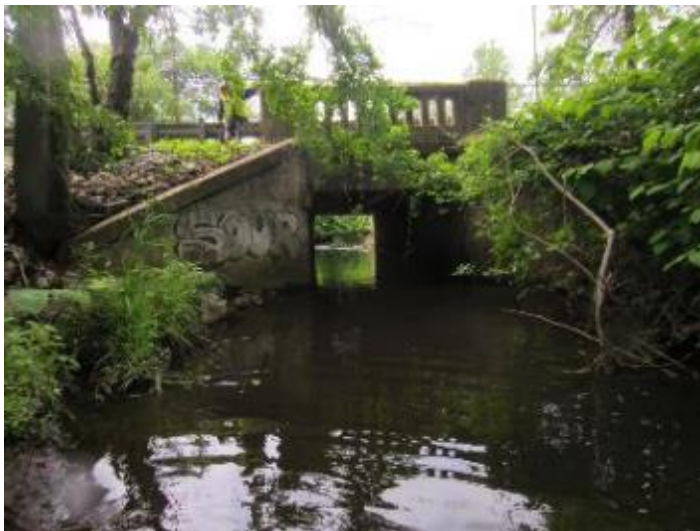
Downstream end of Route 35 bridge (Figure 43) GPS: 40.140683N 74.06115W ±19'; water quality taken (see Table 7 in report); 2 juvenile largemouth bass 30mm TL observed (Figure 44). End at Route 35

Figure 43. Route 35 Bridge/Box Culvert.

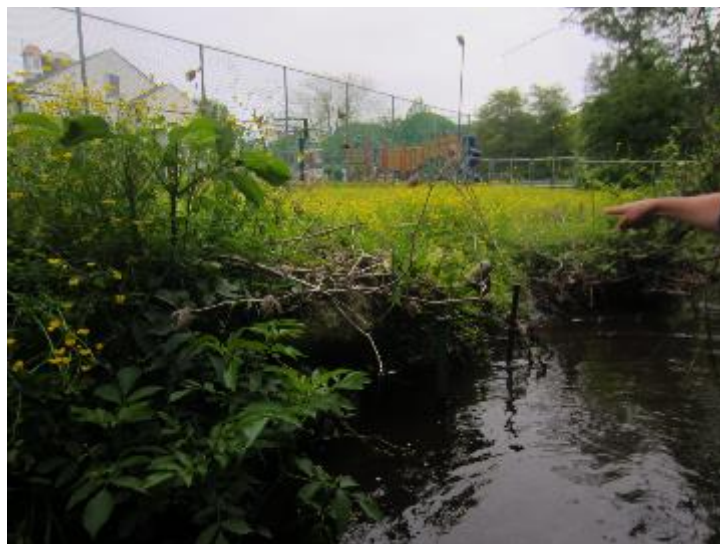
Figure 46. Small, grey pipes emptying into creek at The Brookside School.

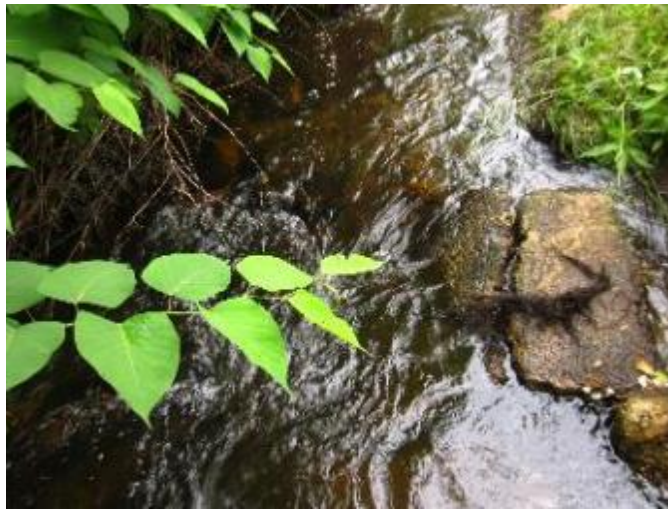
Figure 47. Small step of concrete rip rap fallen into creek from stream bank.

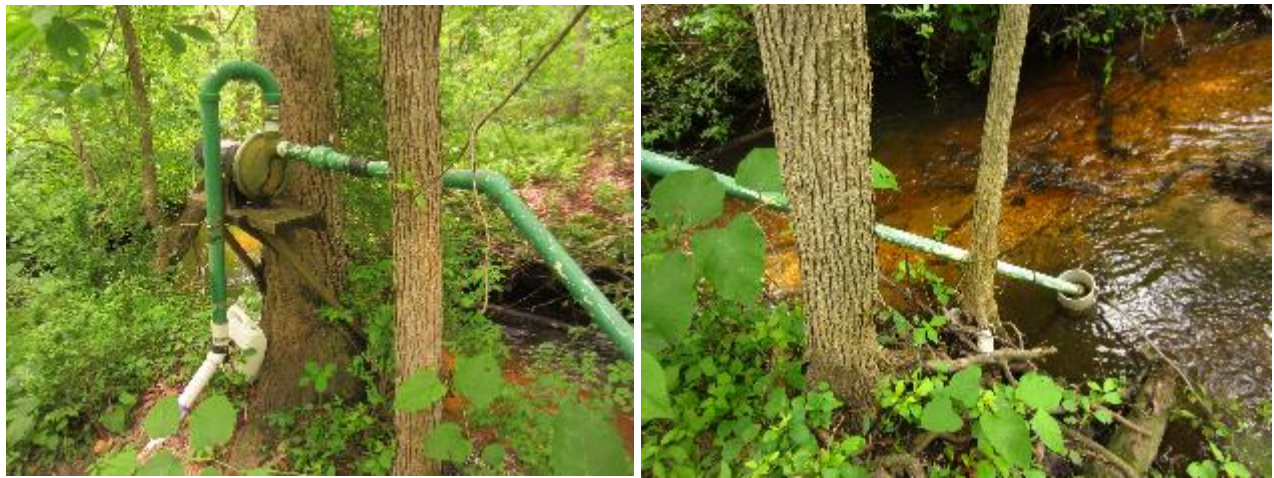
Figure 54. Pump system in-take in creek runs to house on adjacent property. GPS: 40.14161N 74.06663W $\pm 30'$.

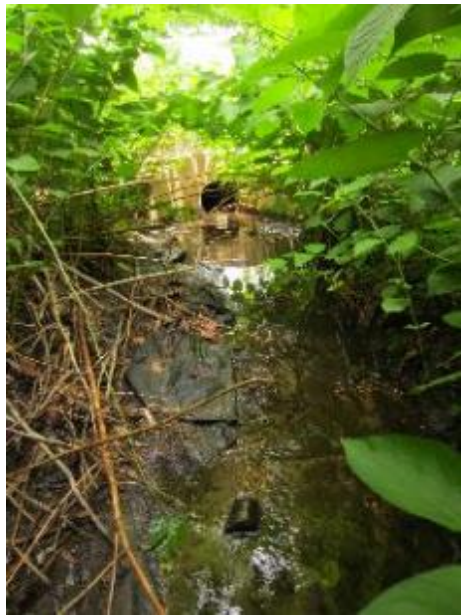
Figure 56. Culvert located approx. 5m below Bailey's Corner Rd. GPS: 40.14214N 74.06772W ±16'.

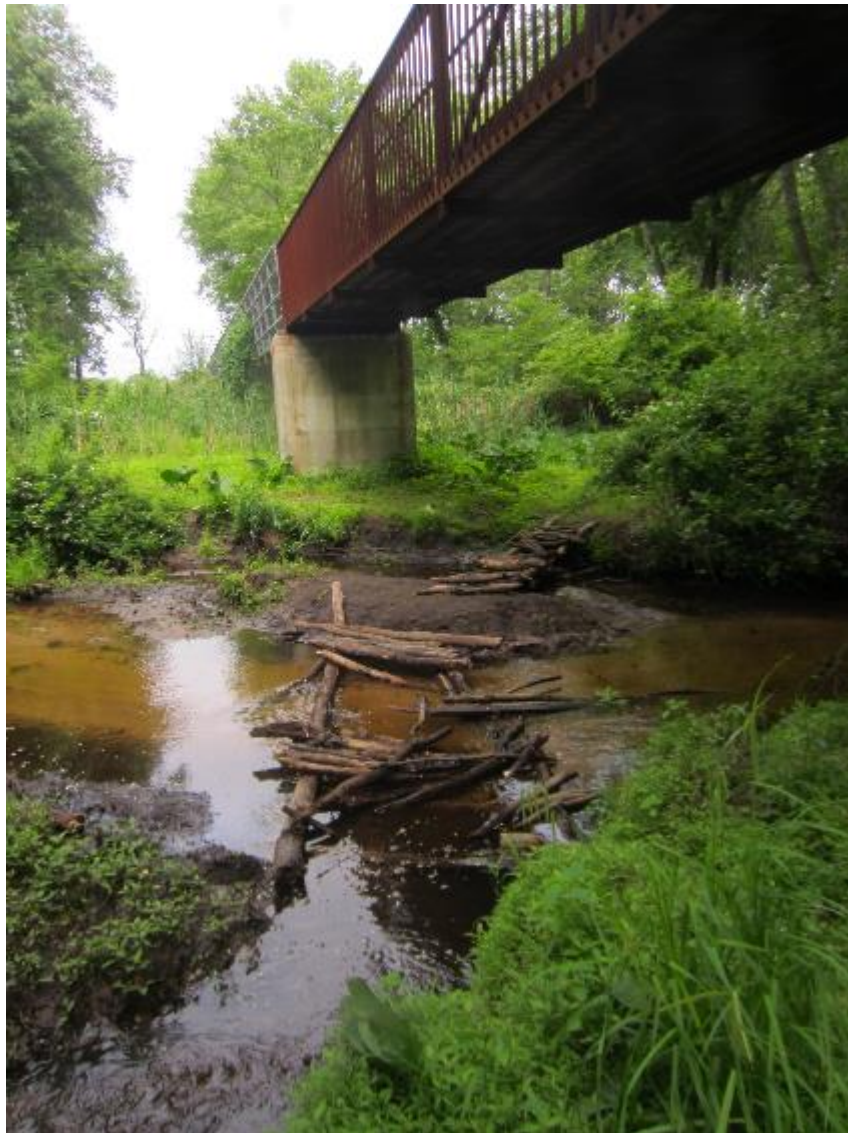
Figure 59. Small check dam located at GPS: 40.14227N 74.06844W. Looking upstream (left photo), looking downstream (right photo).

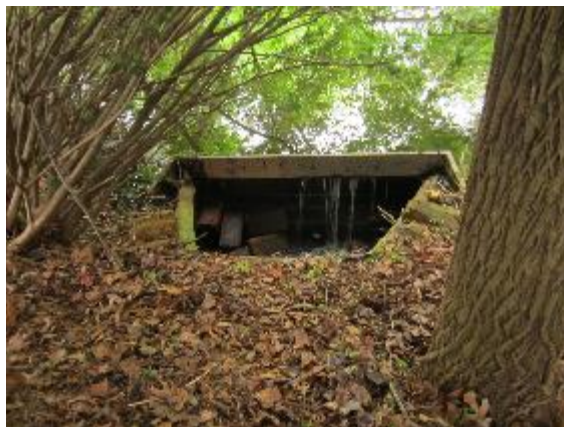
GPS: 40.14116N 74.07741W – **culvert downstream of Hiddenbrook Dr.**; walked downstream of here to check out habitat – lots of skunk cabbage, ferns, bankful width 40-50m; wetted width 1m, a few meandering channels throughout bankful; substrate mainly sand, silt, lots of woody debris, average depth 15-20cm (Figure 65)

Figure 65. Culvert downstream end of Hiddenbrook Dr. (left photo), habitat downstream of Hiddenbrook Dr. (right photo).

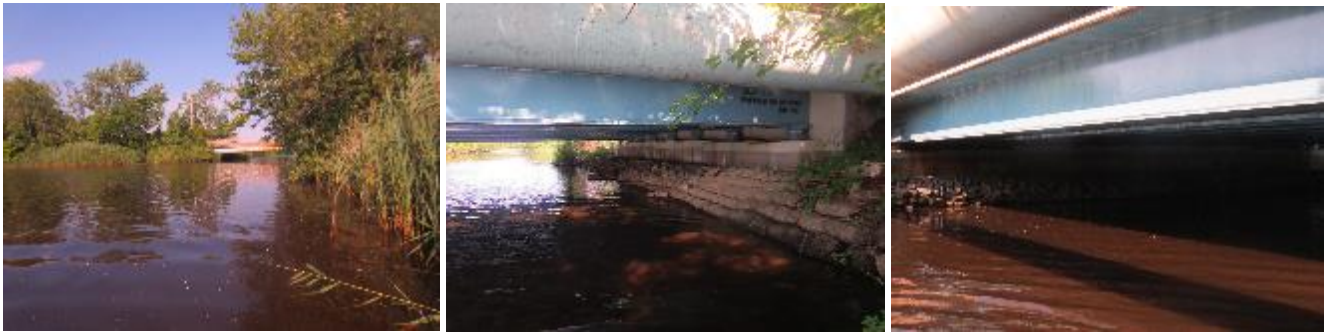
Route 71 bridge GPS: 40.140867N 74.042117W; width about 12m; depth about 150cm (Figure 81)

Figure 81. Route 71 Bridge, Wreck Pond.

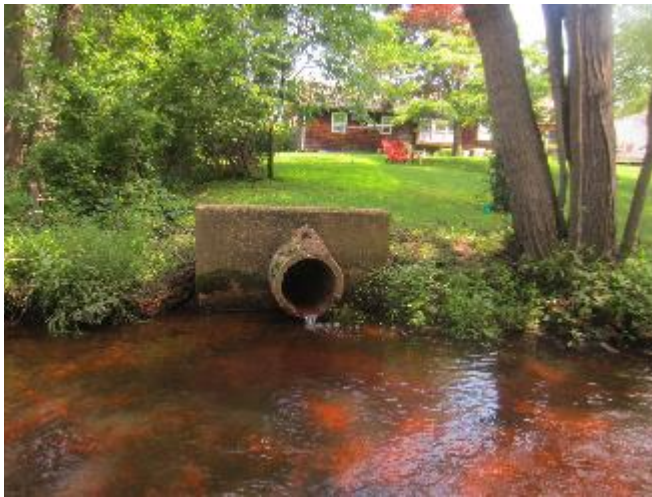
Concrete culvert emptying into creek at upstream end of brown shingled house GPS: 40.14175N 74.05025W ±21' (Figure 86)

Figure 86. Culvert at the upstream end of brown, shingled house. GPS: 40.14175N 74.05025W ±21'.

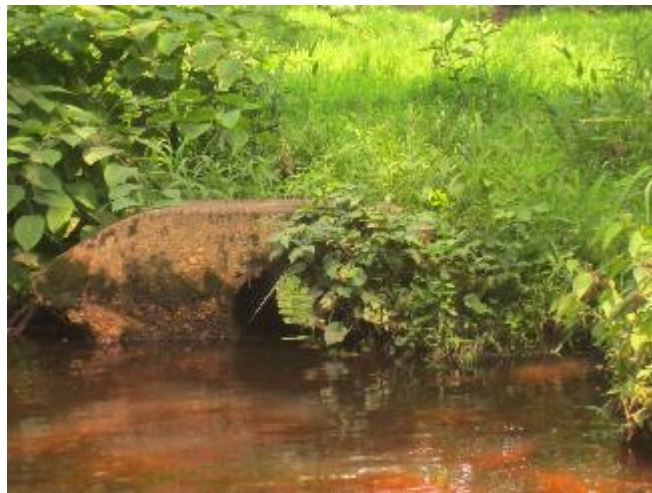
+5m – old pipe in creek, but not connected to any pipe, just a piece of it (Figure 87)

Figure 87. Culvert opening not connected to anything just upstream of culvert in Figure 86.

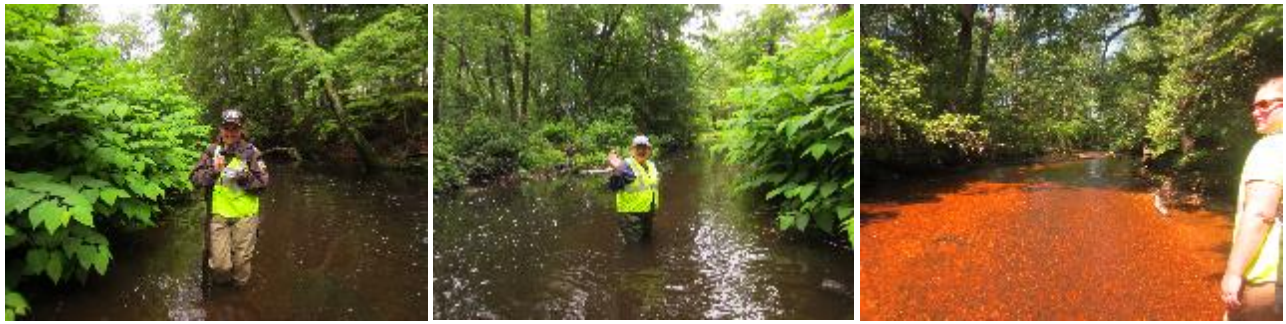
Creek splits upstream end of brick house GPS: 40.143433N 74.05165W ±21', 80% gravel, 20% sand (Figure 88)

Figure 88. Creek splits at the upstream end of this property. GPS: 40.143433N 74.05165W ±21'. Main channel on south side, small, short side channel on north side.

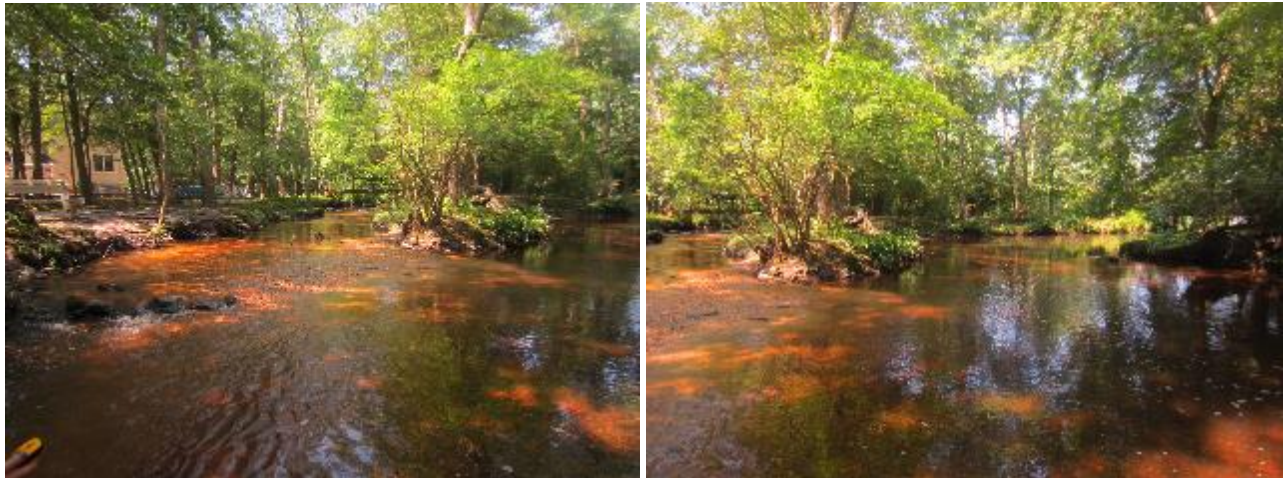
Figure 89. Habitat and stream team members in Wreck Pond Brook, approximately 100m downstream of Old Mill Pond Dam.

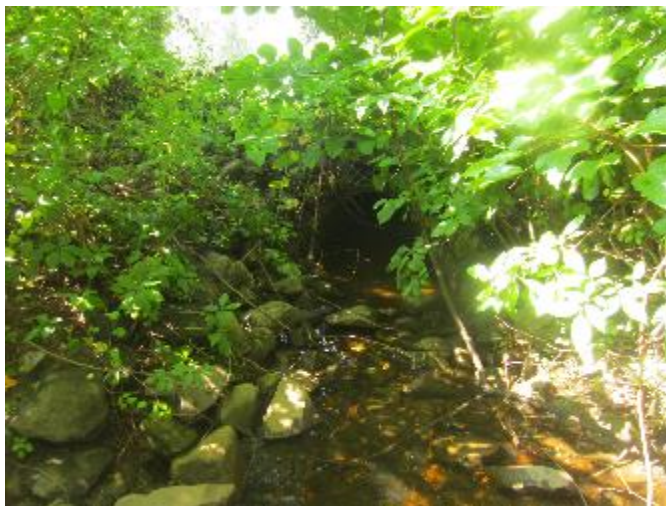
Ocean Road Bridge GPS: 40.14575N 74.056783W ±23'; stream width downstream of bridge about 5m (Figure 92), one painted turtle observed, depth about 50cm+, riparian habitat on both banks about 15m wide; upstream of bridge width about 10m (Figure 93), houses on north bank, each house has a pipe running from it to creek

Figure 93. Upstream of Ocean Rd. Bridge, Wreck Pond Brook.

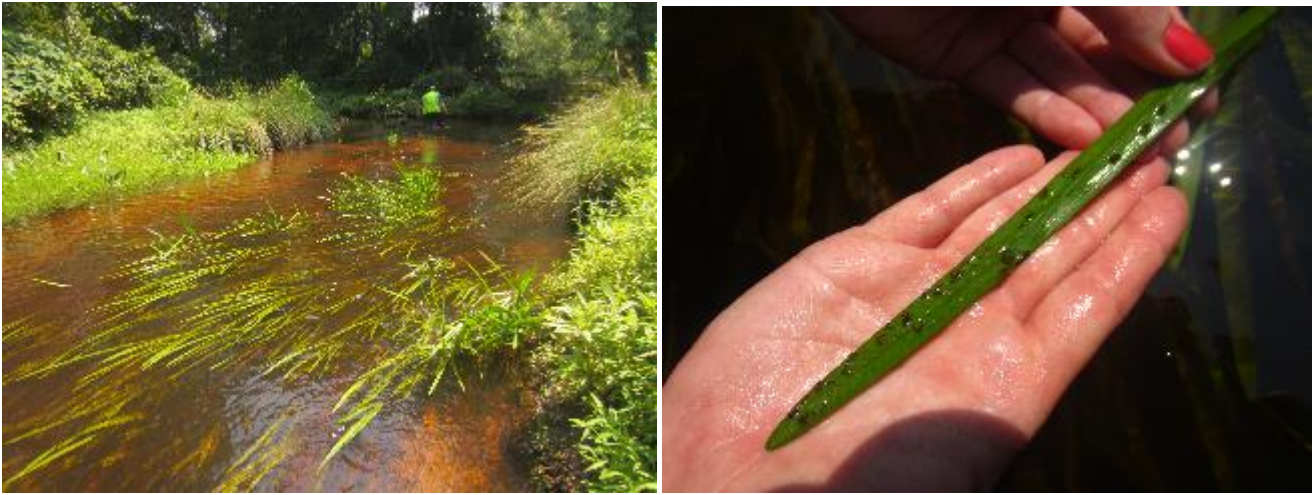
Figure 97. Wreck Pond Brook Habitat further upstream between Route 35 Bridge and Allaire Road.

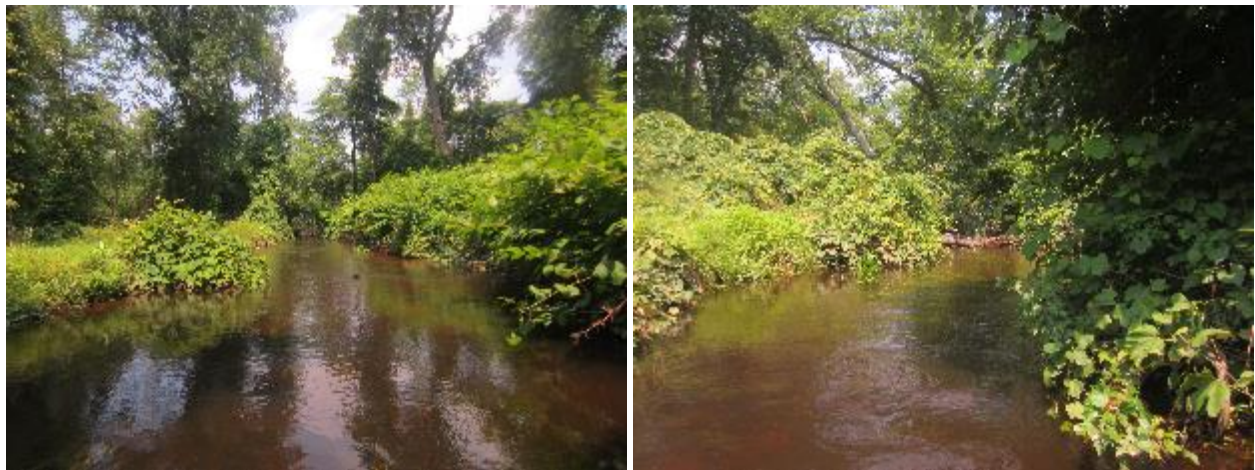
One box turtle observed (Figure 99) GPS: 40.150583N 74.06045W $\pm 20'$; creek wetted width 5m, average depth 30cm, max depth 50cm, substrate 95% gravel 5% sand, 70% instream cover of aquatic vegetation/grasses covered in diptera larvae and pupae and caddisfly larvae and others

Figure 99. Box turtle observed in Wreck Pond Brook at GPS: 40.150583N 74.06045W $\pm 20'$.

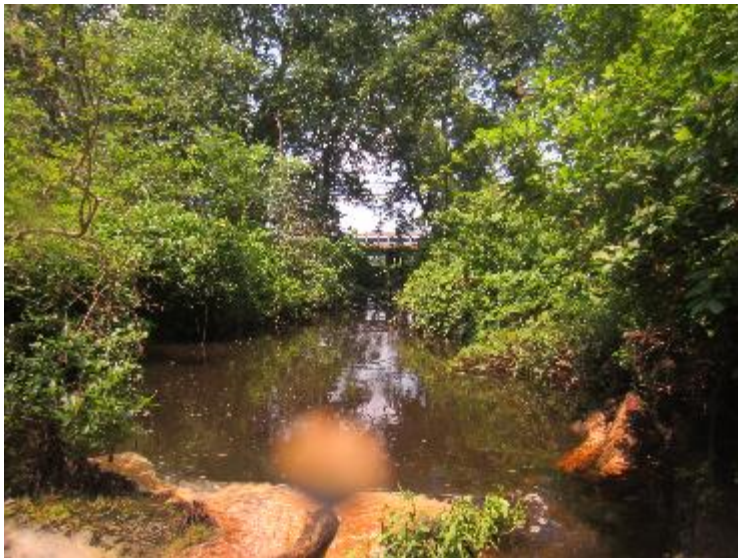
Town houses on east side of creek about 50m away for a 280m stretch downstream of Allaire Road. Figure 100 shows creek habitat through stretch near town houses

Figure 100. Wreck Pond Brook habitat through stretch near townhouses downstream of Allaire Rd.

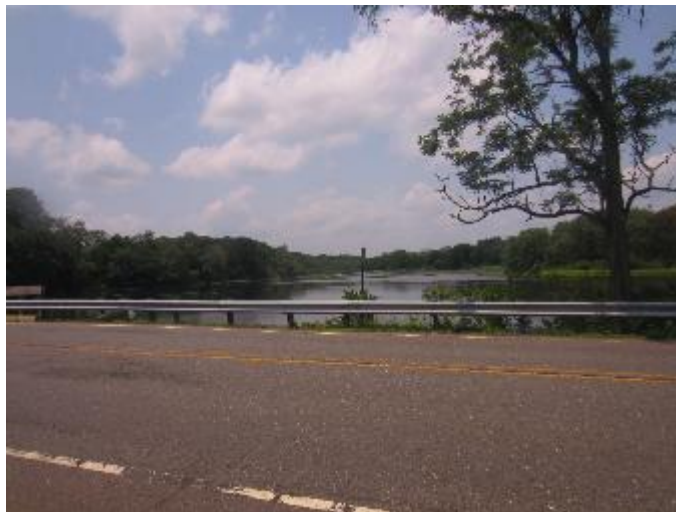
Allaire Rd. Bridge/Dam (definite barrier to fish migration; downstream of Osbornes Pond; Figures 101, 102 and 103) GPS: 40.15295N 74.061533W $\pm 17'$; water quality taken (see Table 9 in report)

Figure 102. Wreck Pond Brook, Allaire Road Bridge and Dam. GPS: 40.15295N 74.061533W ±17'.
