WRECK POND BROOK WATERSHED

2015 Habitat Assessment Report

November 2015

Prepared by:
Jenna Krug, Habitat Restoration Coordinator
Capt. Al Modjeski, Habitat Restoration Director
American Littoral Society

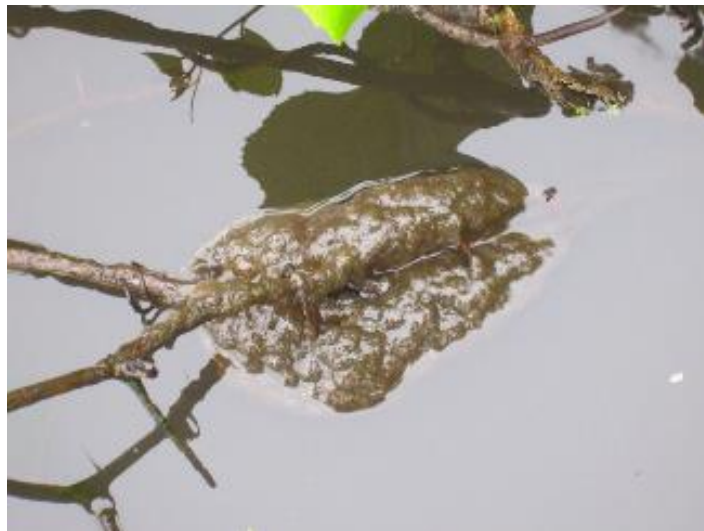
Figure 3. Freshwater Bryozoan (Pectinatella sp.)

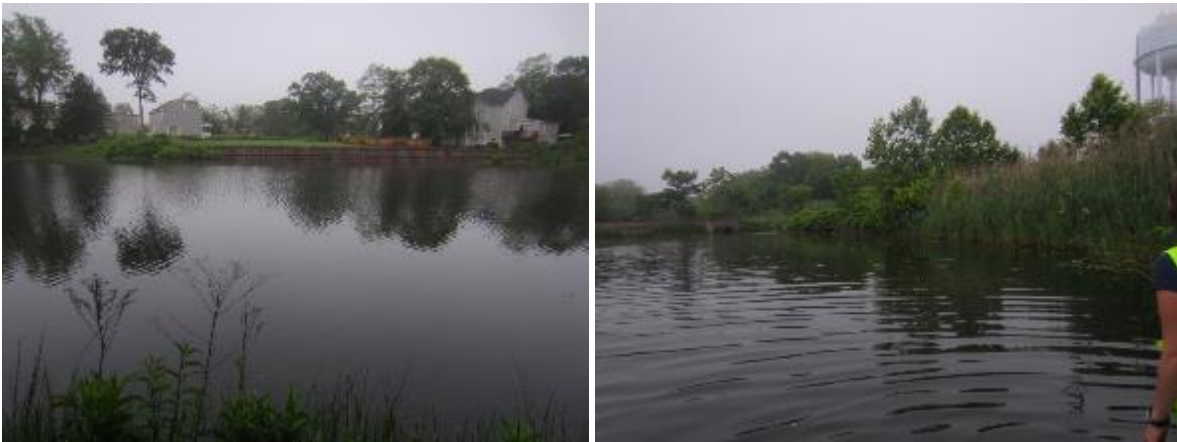
+10m above fence is a narrow and shallow (avg. 5 cm depth) creek trickling into the main pond with an oil sheen on surface (Figure 7). Concrete on west bank, high density of Japanese knotweed. GPS coordinates – 40.14473N 74.03515W

Figure 7. Left-South side of Black Creek (below RR tracks). Right- North side.

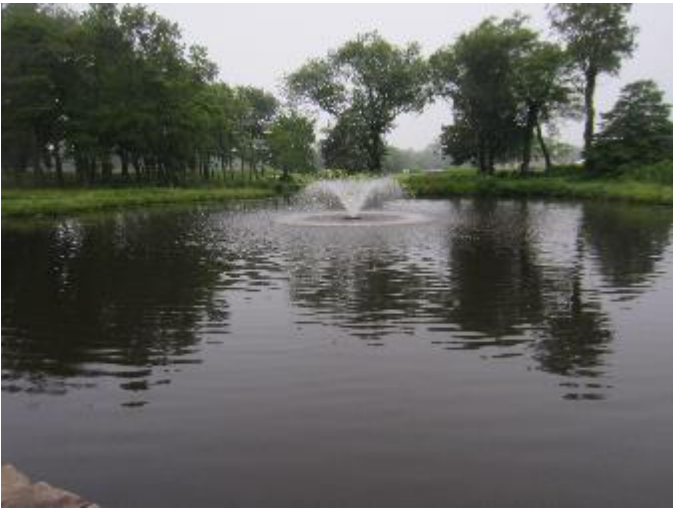
Figure 16. Second pond on Spring Lake GC property.

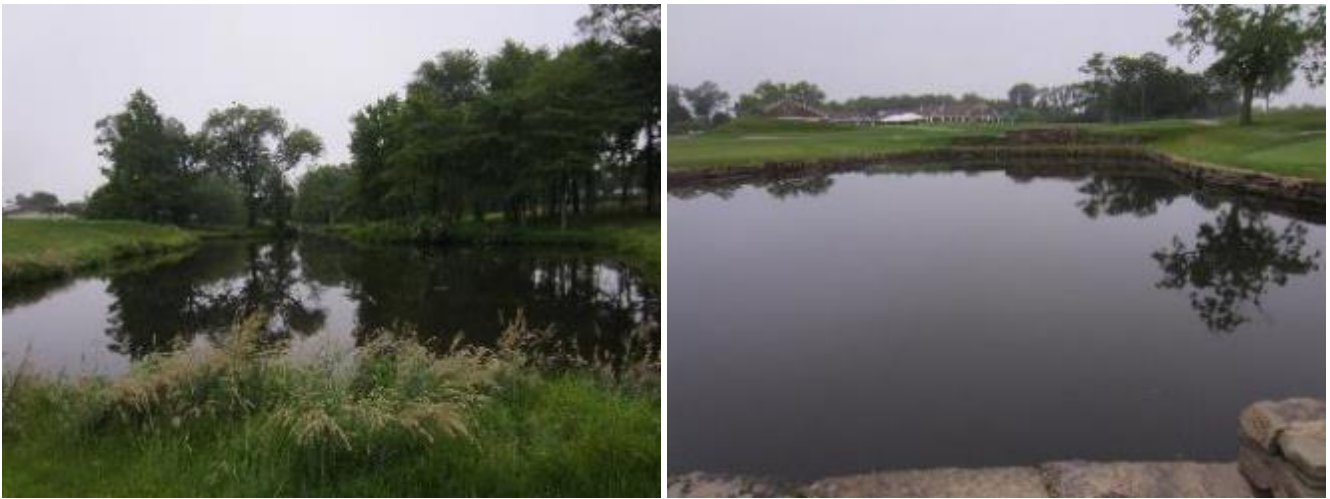
Figure 18. Downstream (upper) and upstream (lower) ends of fourth pond.

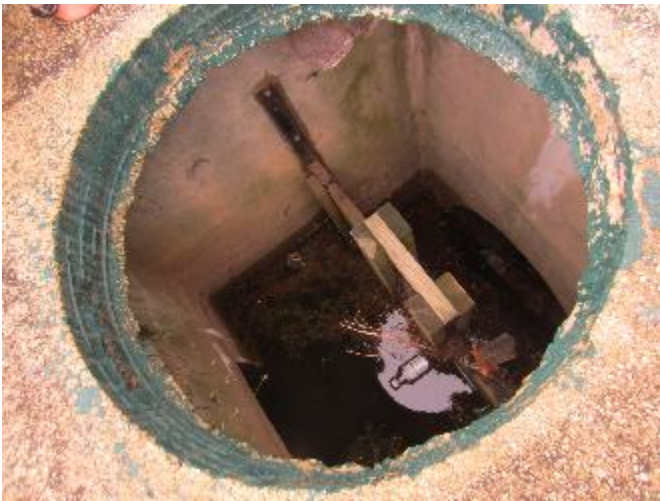
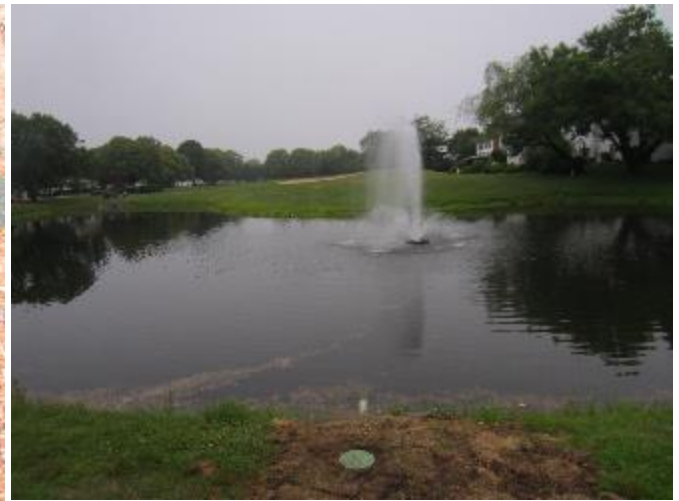
Figure 24. Upstream of Warren Rd. first pond in Fairway Mews Golf Course.

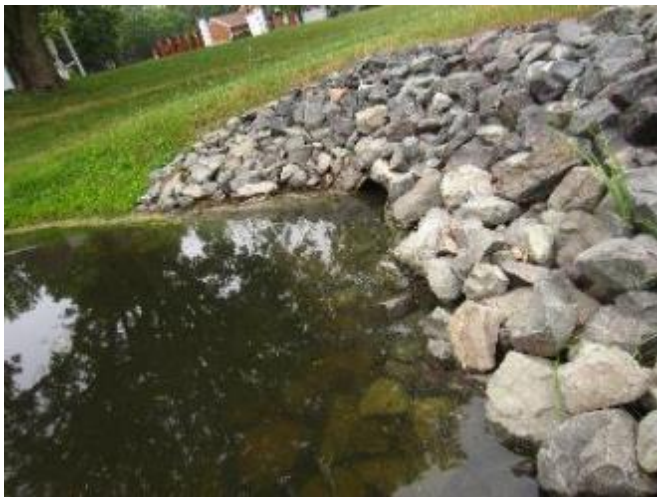
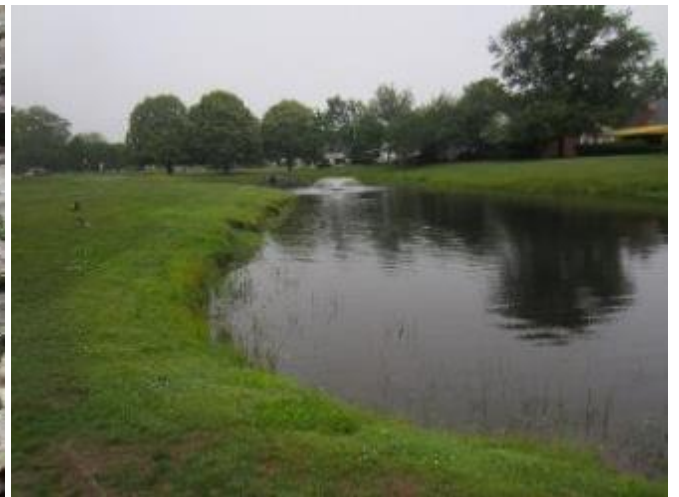
Figure 25. Upstream end of first pond and second pond in Fairway Mews GC.

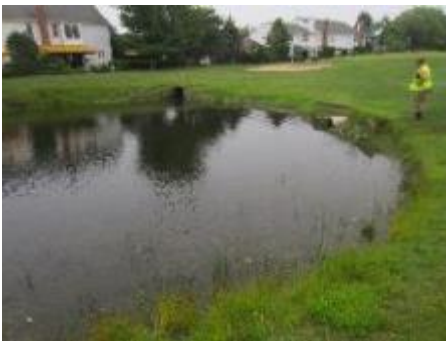
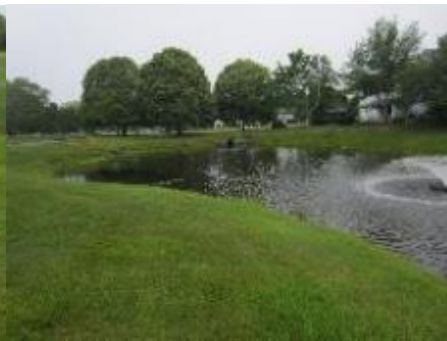
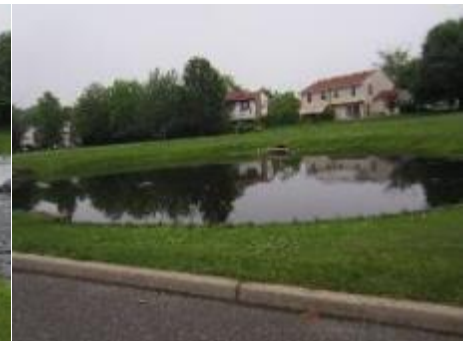
Figure 26. Multiple pipes/culverts emptying into/connecting (?) ponds throughout Fairway Mews GC.

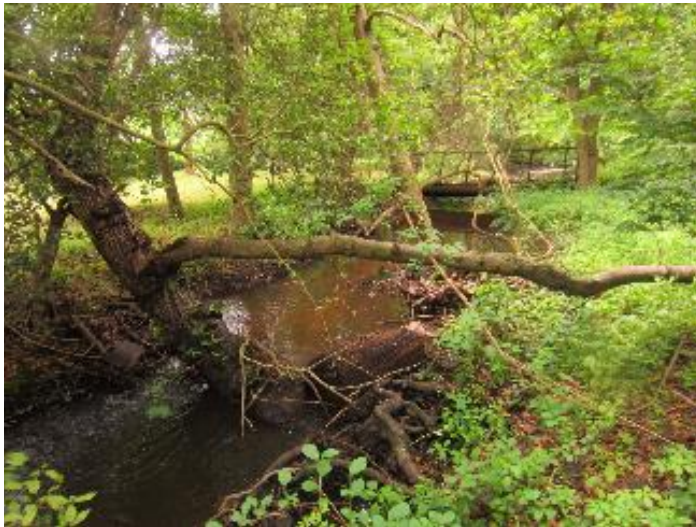
Figure 30. Fallen tree debris with old wooden footbridge in the distance.

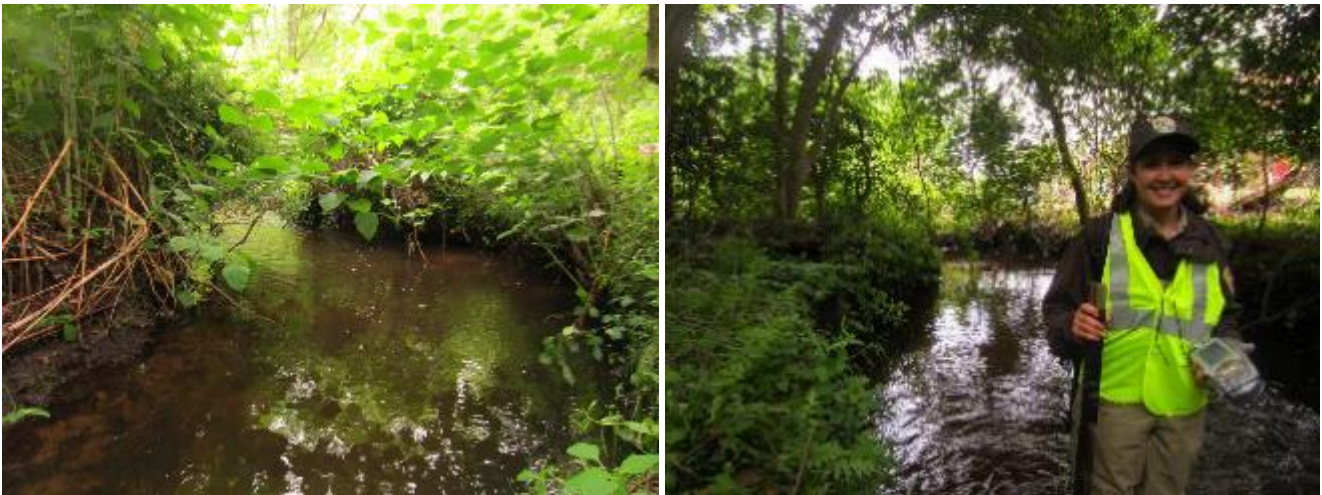
Figure 36. Creek habitat where 150+ juvenile fish (possible alewife) were observed on June 3, 2015.

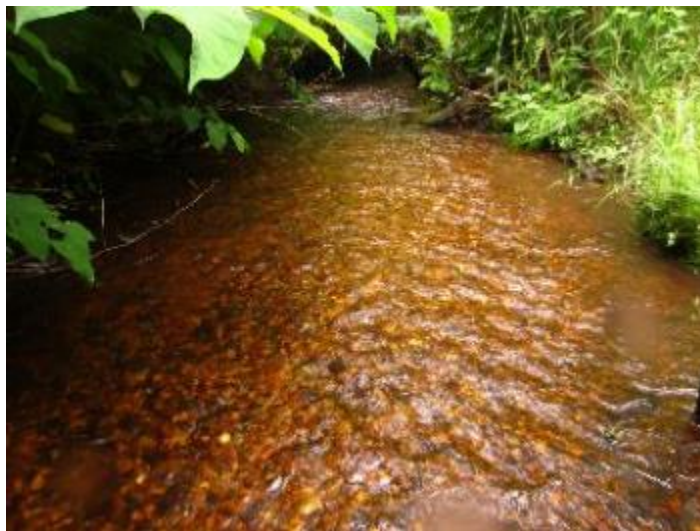
Next 30m creek is overgrown with brush, walked around on bank; lots of Japanese knotweed on both banks as you get closer to Route 35 (Figure 42)

Figure 42. Creek downstream of Route 35, Japanese knotweed on banks.

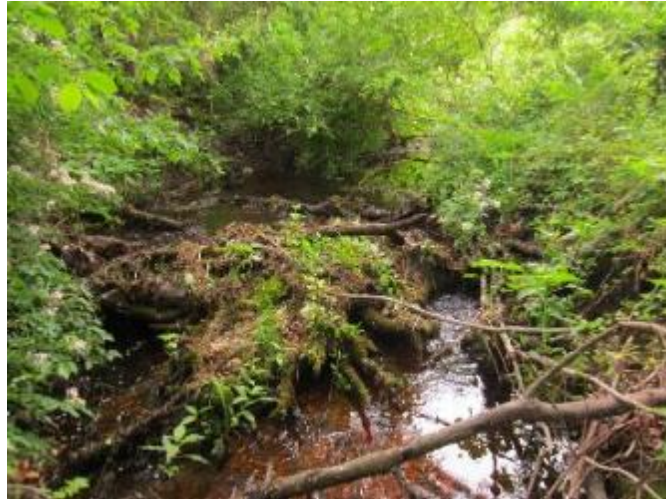
Figure 61. Black pipes emptying into creek below Crystalbrook Dr.

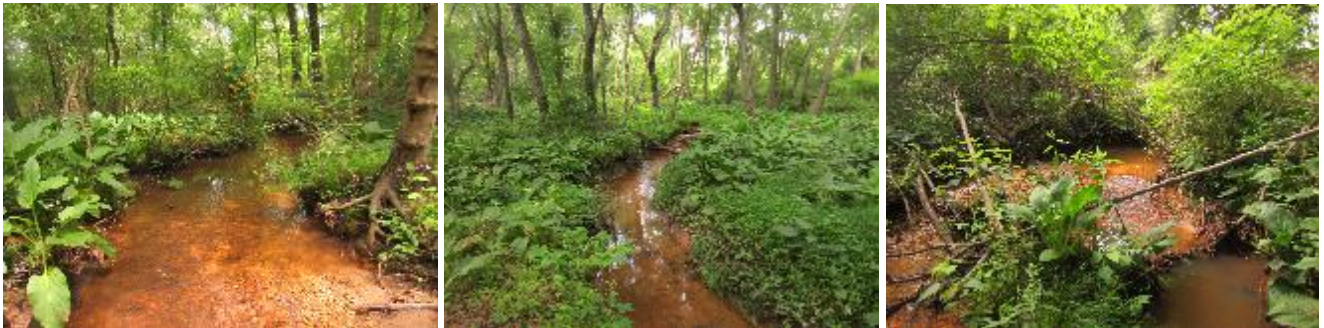
Broken wooden weir GPS: 40.15263N 74.09178W ±11' (Figure 73)

Figure 73. Broken wooden weir. GPS: 40.15263N 74.09178W ±11'.

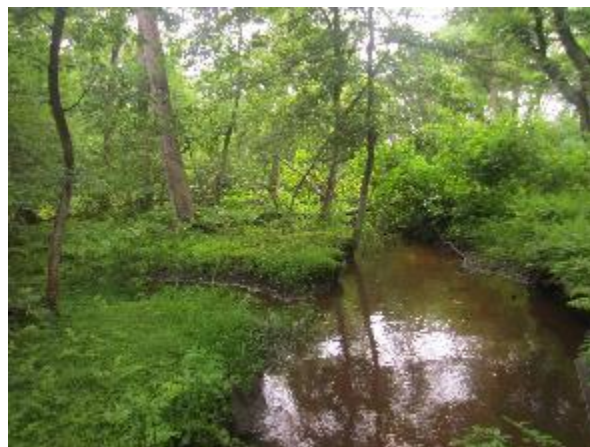
Long, black pipe GPS: 40.14462N 74.07369W ±27' (Figure 76); depth about 130cm about 3m upstream of this

Figure 76. Long, black pipe in creek GPS: 40.14462N 74.07369W ±27'.

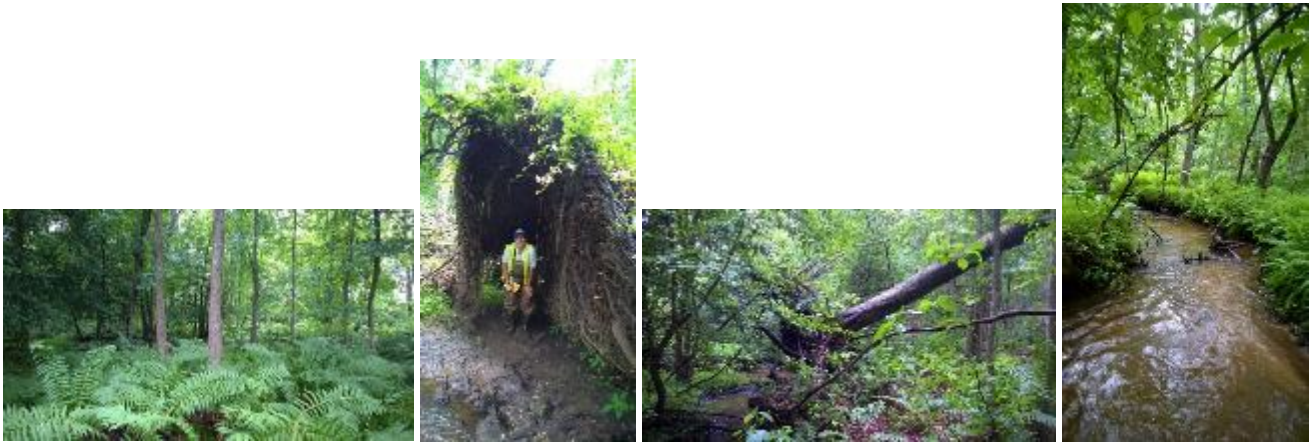
Large, concrete pipe at GPS: 40.14717N 74.07893W ±36' not connected to anything; one green frog (Figure 78)

Figure 78. Large, single concrete pipe at GPS: 40.14717N 74.07893W ±36' (looking upstream left photo, downstream right photo).

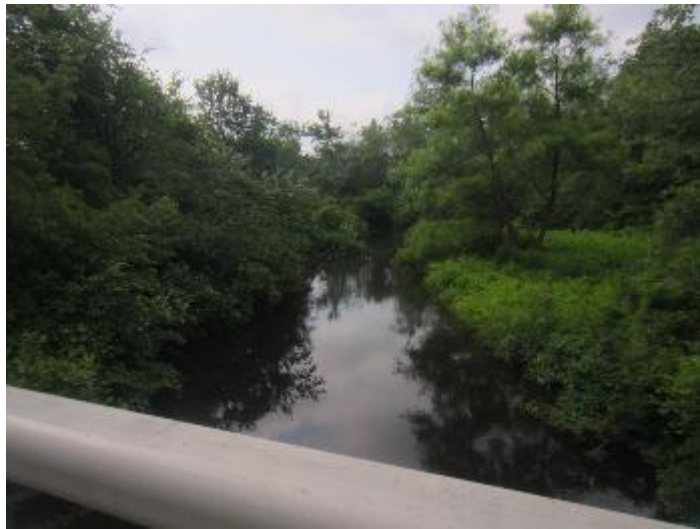
JULY 1, 2015 – sunny and clear, rained last night; **started at Old Mill Pond Dam GPS: 40.144222N 74.053566W (Figure 91; definite barrier to fish migration)**

Figure 91. Old Mill Pond Dam and Old Mill Pond.

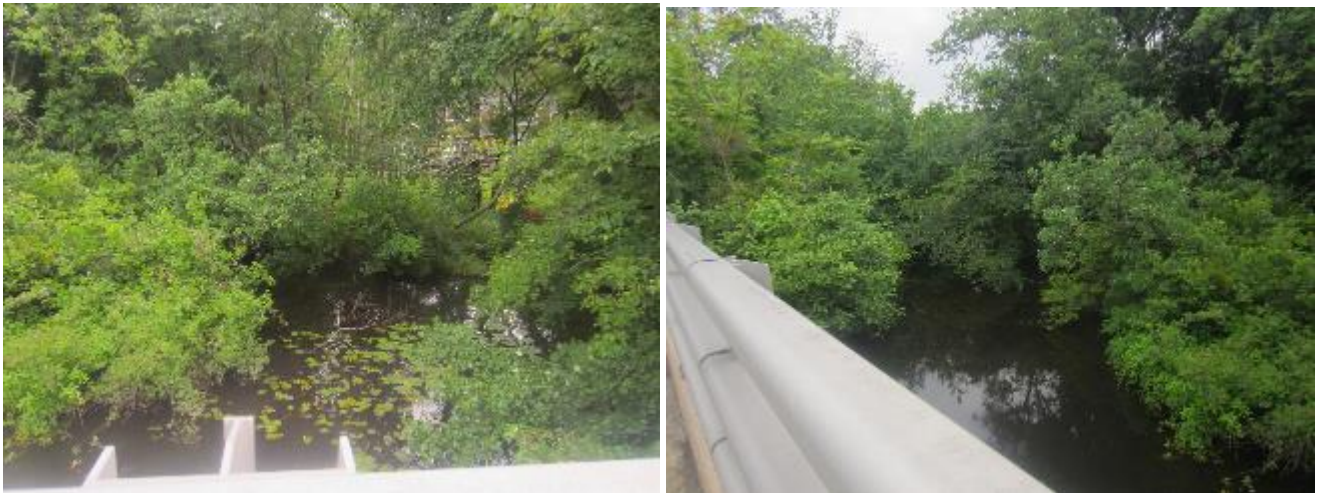
Figure 92. Downstream of Ocean Rd. Bridge, Wreck Pond Brook.

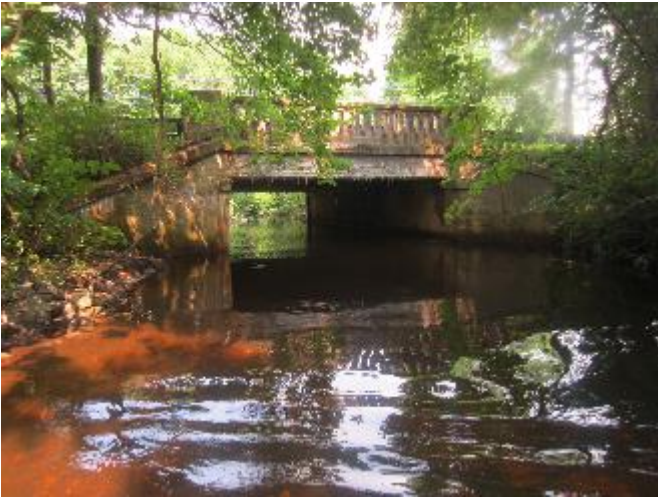
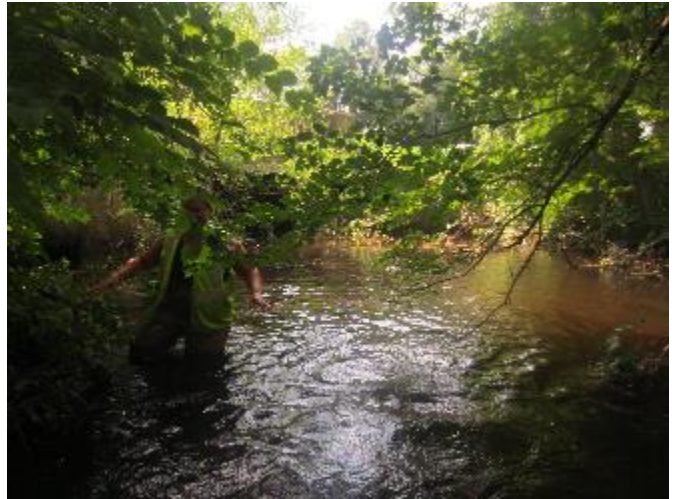
10m downstream of Route 35 Bridge, culvert on south side (Figure 94) GPS: 40.1467N 74.057483W (very weak signal); wetted width 7m, depth 35cm

Figure 94. Culvert located at approximately GPS: 40.1467N 74.057483W.

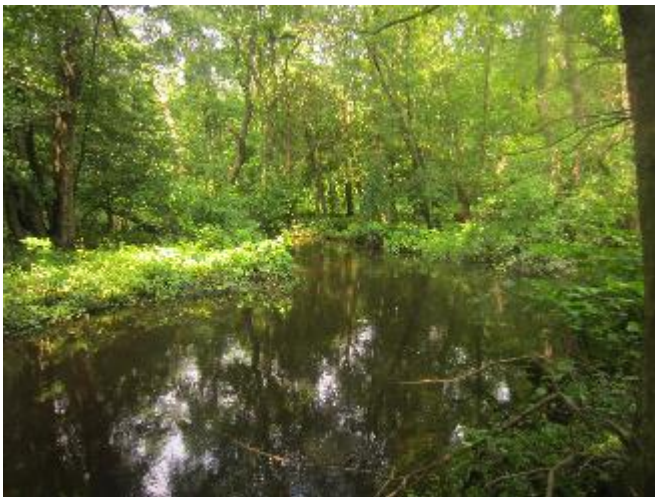
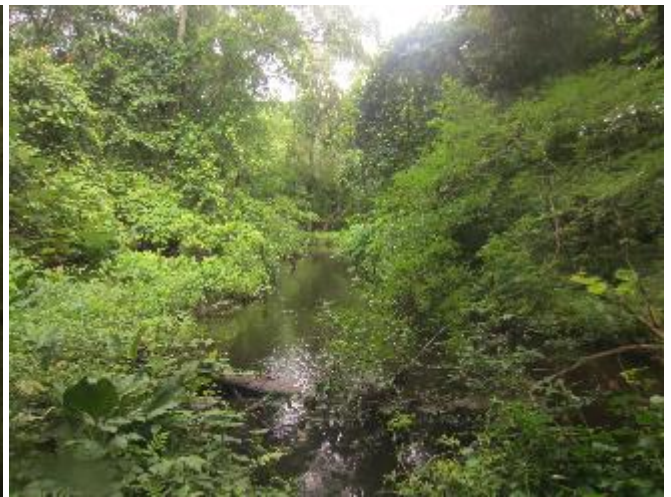
Upstream of Route 35 Bridge 100cm average depth, 10m width, gravel/muck bottom, sink in about 20cm (Figure 95)

Figure 95. Route 35 Bridge (downstream on left, upstream on right), Wreck Pond Brook.

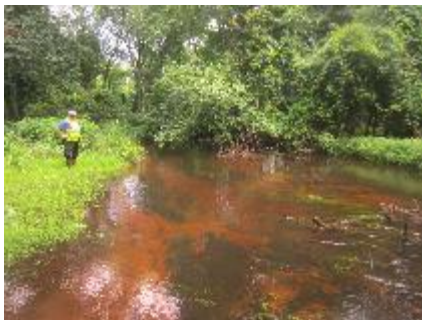
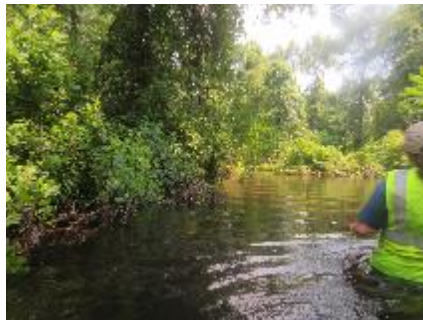
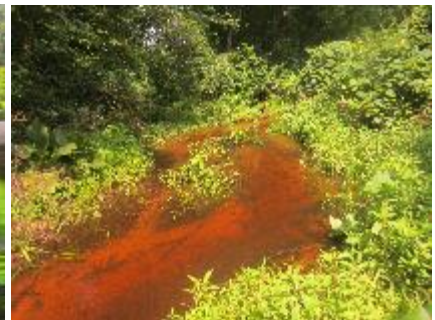
Further upstream the bottom turns sandy throughout reach up to Allaire Road with few spots of silty/mucky bottom; riparian habitat extending 20+m on both sides of creek; creek is sinuous, branching with multiple channels, wetted width 1.5-5m (Figure 96 and 97)

Figure 96. Habitat upstream of Route 35 Bridge, Wreck Pond Brook.
